# LOOK TRAILER AXLE HANGER BRACKET

| Recall Number: | 19V-619 | | |
| Product: | Trailer Axle Hanger Bracket | Labor | 0.5 Hour (inspection per trailer) |
| Date: | August 22, 2019 | Rate: | 2.0 Hours (procedure per axle) |

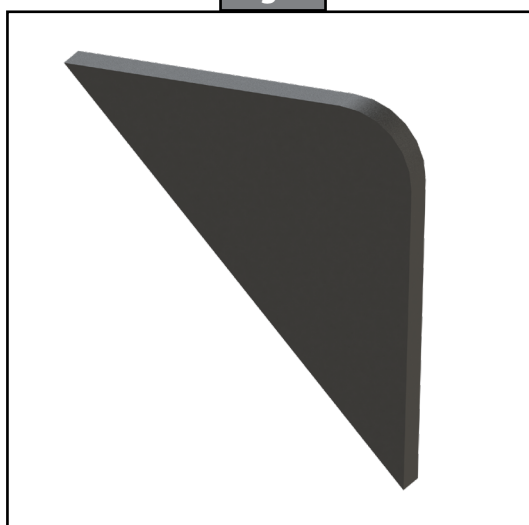
Fig. 1

The intent of this document is to describe an inspection of the axles of the models listed to determine if the axle hanger brackets have the correct reinforcements. If a hanger bracket does require reinforcement, an aluminum gusset (Fig. 1) will be welded on both ends of the bracket.

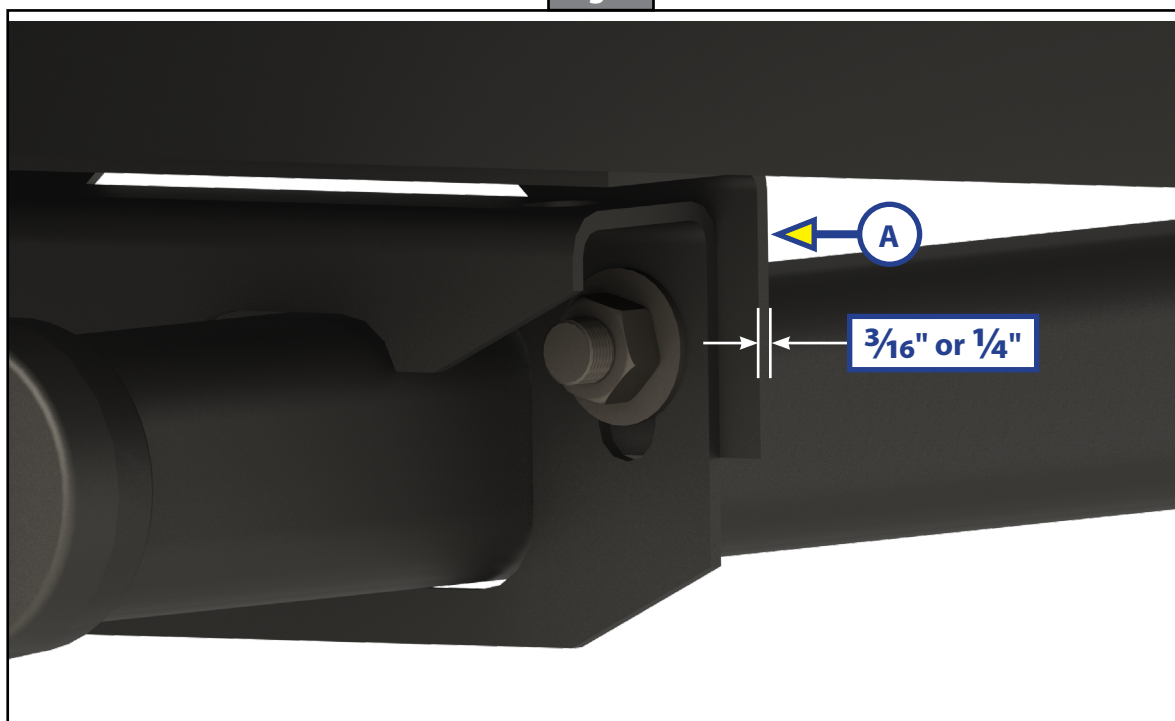
Fig. 2

Measure the thickness of each aluminum side mount at Fig. 2A. If the mount measures  $\frac{3}{16}$ ", then gussets will need to be added. A mount that measures  $\frac{1}{4}$ " is the revised version and no action is necessary.
