| Recall Number: | 21V294 | | |
| Product: | Trailer Axle Hanger Bracket | Labor | 0.5 Hour (inspection per trailer) |
| Date: | May 6, 2021 | Rate: | 2.0 Hours (procedure per axle) |

## Purpose

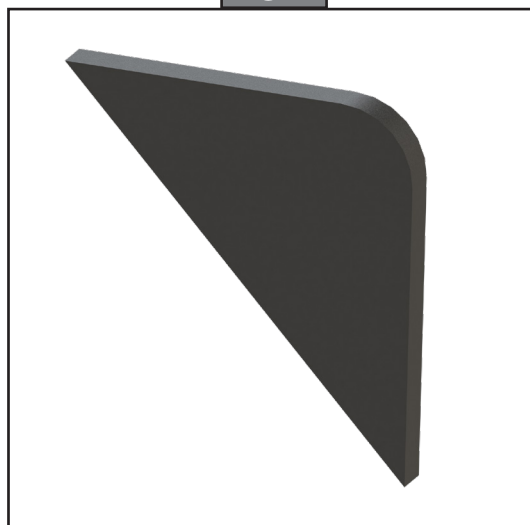
**Fig. 1**

The intent of this document is to describe an inspection of the axles of the models listed to determine if the axle hanger brackets have the correct reinforcements. If a hanger bracket does require reinforcement, an aluminum gusset (Fig. 1) will be welded on both ends of the bracket.

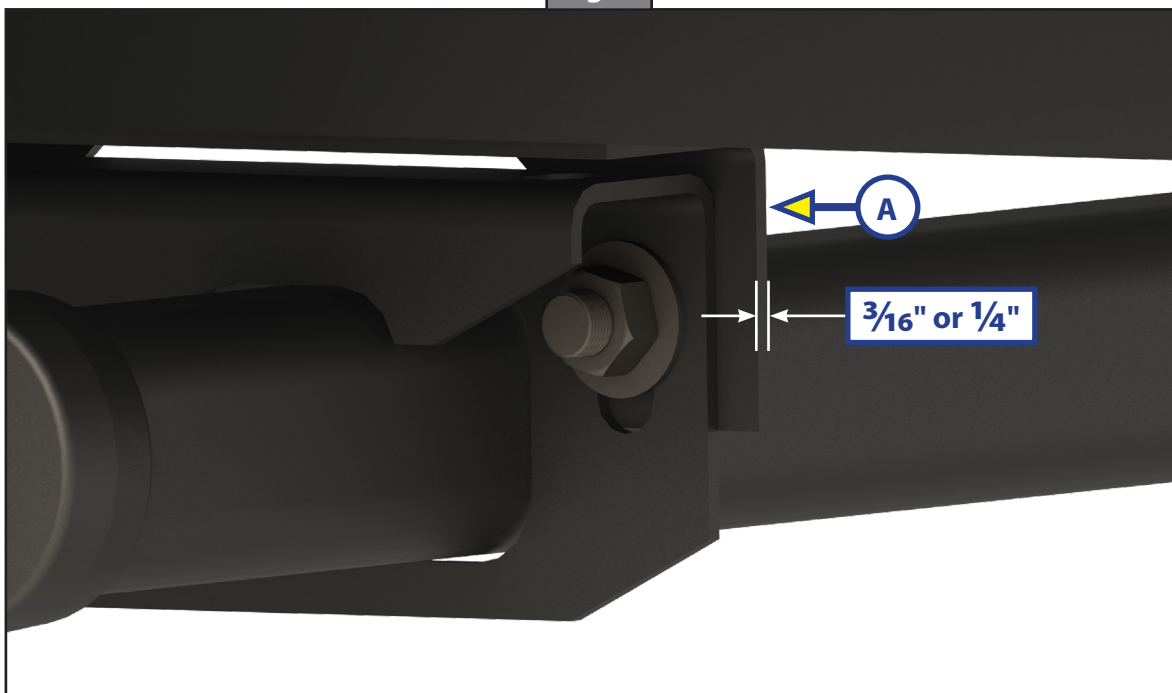
Fig. 2

Measure the thickness of each aluminum side mount at Fig. 2A. If the mount measures  $\frac{3}{16}$ ", then gussets will need to be added. A mount that measures  $\frac{1}{4}$ " is the revised version and no action is necessary.
