# KZ-RV SOLERA® AWNING SMART ARM CONTROLLER REPLACEMENT RECALL #18V-242 LABOR FLAT RATE: 0.3 HOUR TC (TRANSPORT CANADA) #2018286

## KZ-RV Solera Awning Smart Arm Controller Recall: #18V-242/ TC (Transport Canada) #2018286

**NOTE:** This document is applicable to all Solera Smart Arm awnings built prior to 6/3/2018.

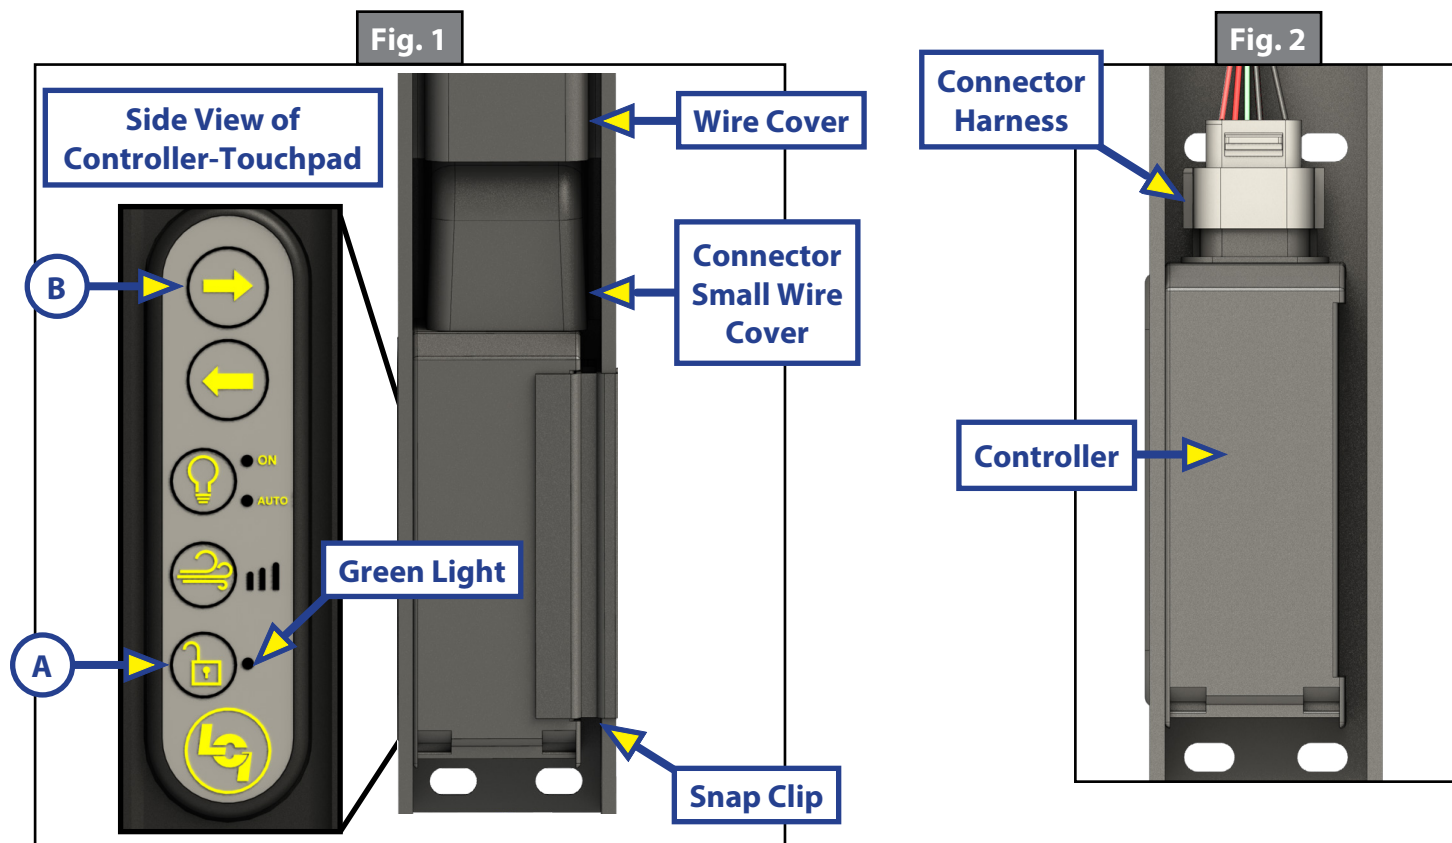
1. Press and hold the unlock button (Fig. 1A) until the green light illuminates.
2. Press and hold the extend arrow button (Fig. 1B) until the awning is fully extended.
3. Remove the snap clip, wire cover and connector small wire cover (Fig. 1) from the drive side awning arm assembly.
4. If equipped with an infrared (IR) sensor (Fig. 4), disconnect by unplugging it from the bottom of the smart arm controller (Fig. 3) and retain for reinstallation.
5. Remove the smart arm controller from the drive side mount arm.
6. Detach the connector harness (Fig. 2) from the smart arm controller.

3. Plug the connector harness into the smart arm controller (Fig. 2).
4. Fit the smart arm controller back into place so the touchpad face of the controller fits into the hole in the drive side mount arm, then push the snap clip into place (Fig. 1).
5. Reinstall the connector small wire cover and wire cover (Fig. 1), in that order.

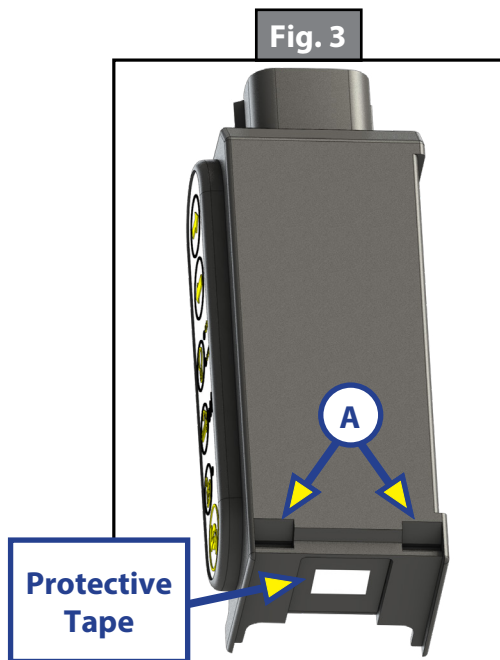
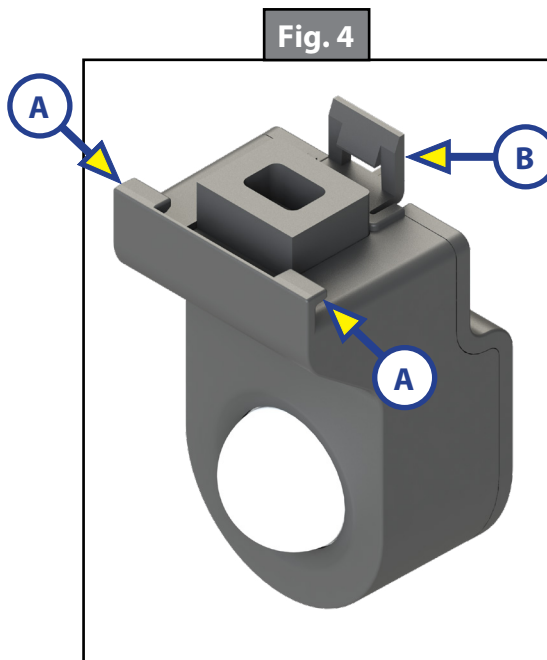
1. Remove the protective tape (Fig. 3) covering the connection pins at the bottom of the smart arm controller.
2. Align the IR sensor (Fig. 4) to the bottom of the smart arm controller with the white sensor dome facing outward. Line up notches on the front of the controller (Fig. 3A) with the tabs of the IR sensor (Fig. 4A), then push the IR sensor up and back to lock the sensor into place.

**NOTE:** The tab on the back of the IR sensor (Fig. 4B) will snap onto a tab at the bottom of the smart arm controller.

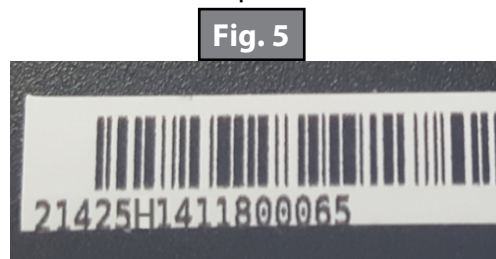
Please submit your completed work order with full unit information (including 17-digit VIN, Brand/Model and Date of Mfr) directly to LCI via email. Your submission must include a clear photo of the destroyed controller with the controller serial number (Fig. 5). Please send with repair documents via email to [customerservice@lci1.com](mailto:customerservice@lci1.com).

**NOTE:** Serial number is found on the side of the controller opposite the touchpad.
