**Retract the Room.**

**Loosen the interior top cable (Figure 1)**

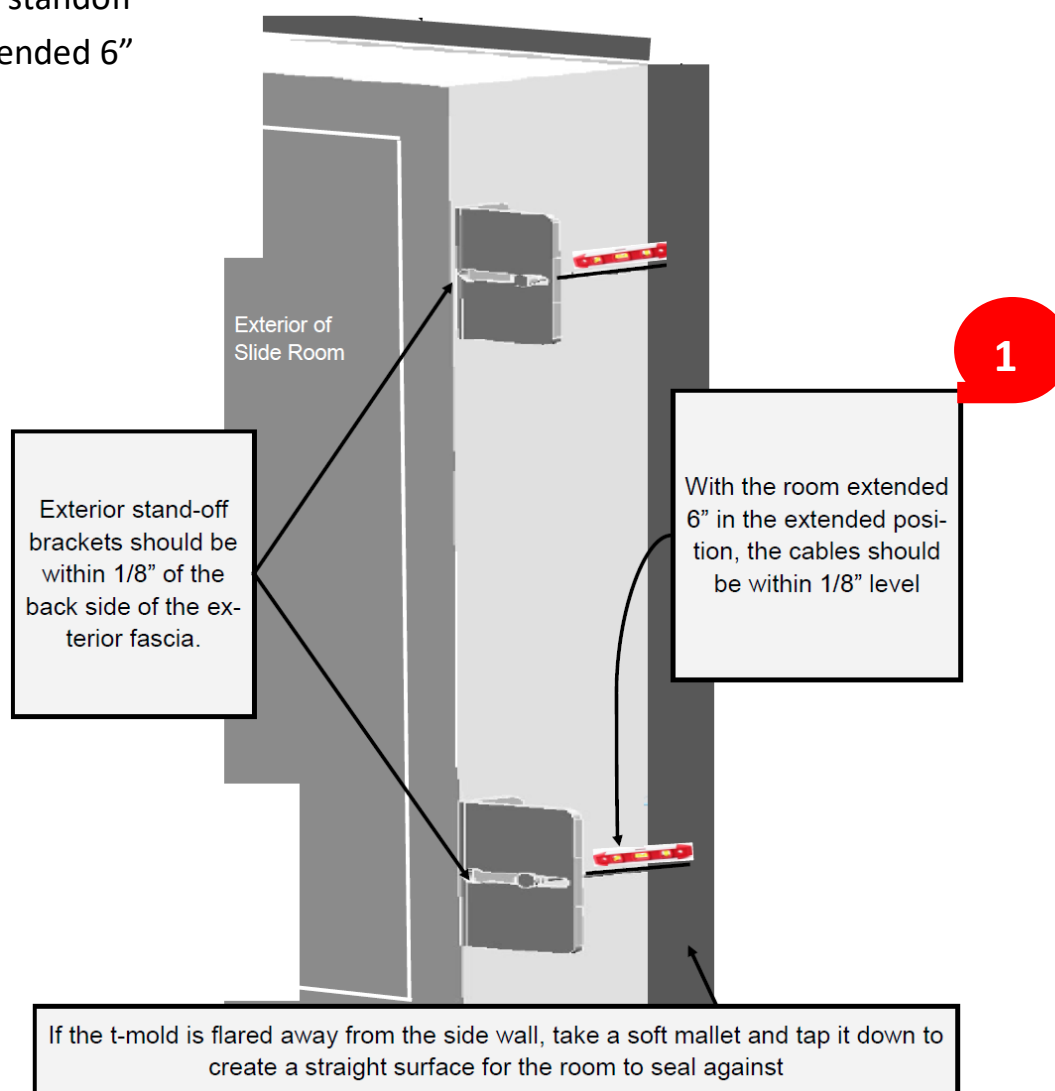
Before adjusting, check the standoff brackets with the room extended 6" into the out position.

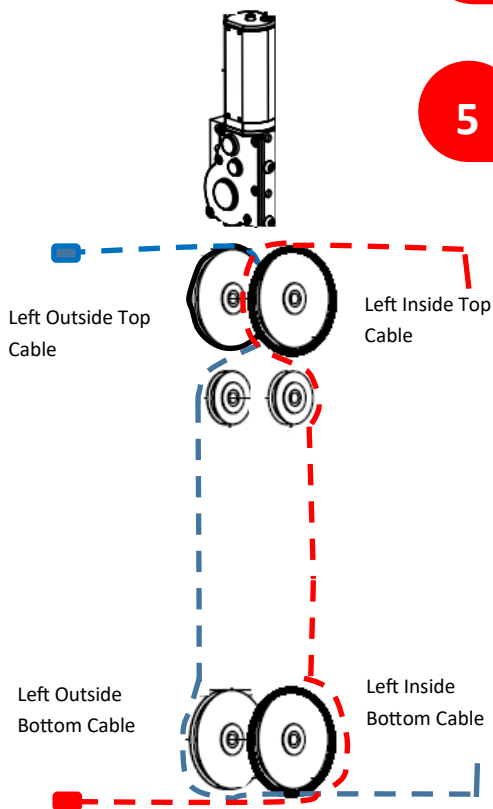
Figure 1

**Tighten the interior top cable (Figure 1).**

Tighten until the cable can be pulled up and pushed down 1/2" with your thumb and index finger.

Left (from interior) Cable Routing

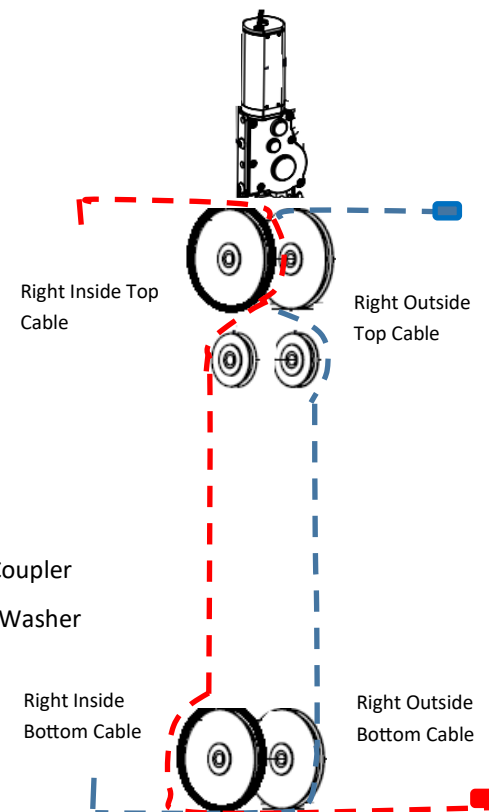
Figure 3

Right (from interior) Cable Routing

Coupler  
Washer

In the event there is still slack in the cable or chain with the above adjustment, it may be necessary to add a shim with additional washers between the existing washer and coupler. **(Figure 3)**

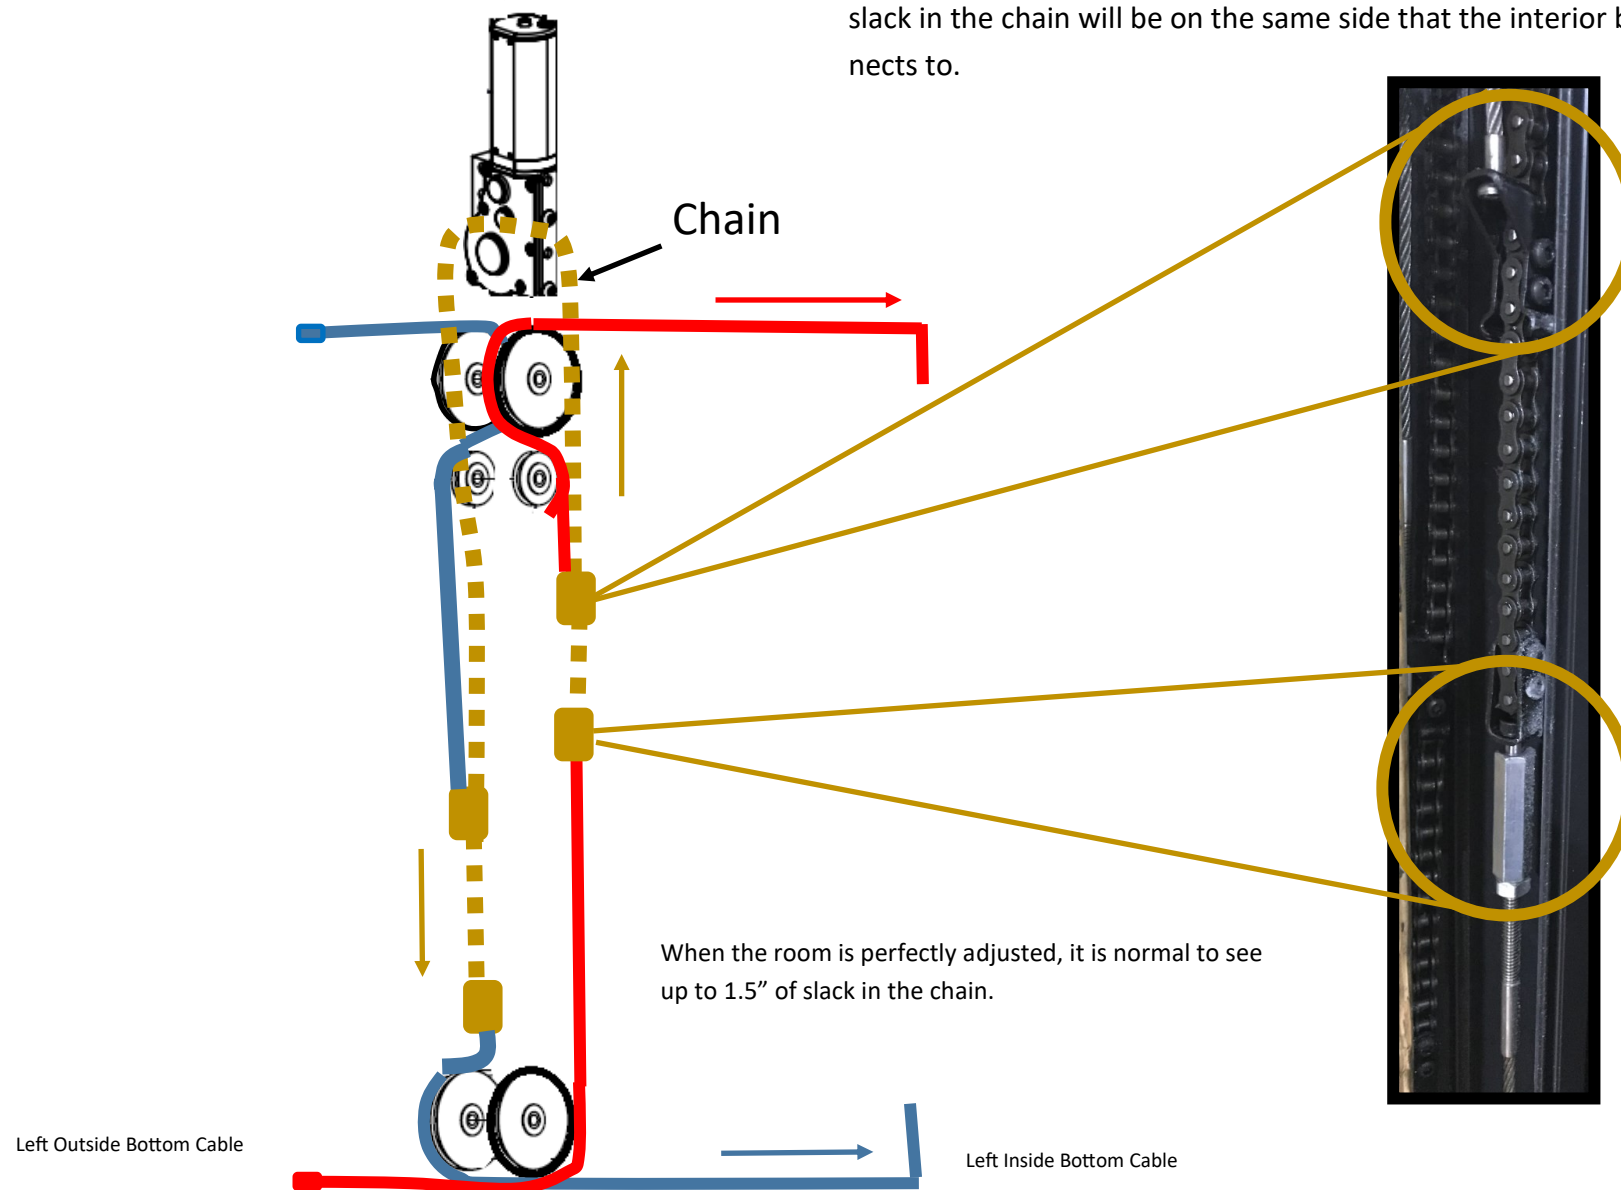
## Left (from interior) Cable Routing Retracted

Retracting the room to the in position, pulls the chain towards the motor. The slack in the chain will be on the same side that the interior bottom cable connects to.
