# LCI 8800 SERIES WINDOW REPAIR

| TSB Number: | 15-001-19 |
| Product: | LCI Window Repair |

Repair of specific 8800 Series LCI windows is needed to eliminate potential leaks and reinforce bond.

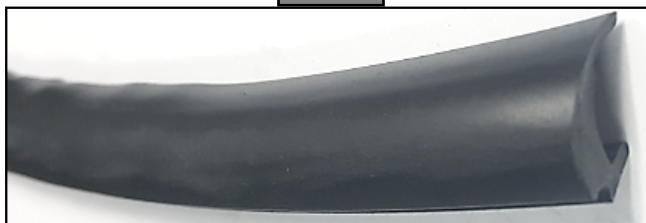
Fig. 1

1. **Vinyl:** Vinyl (Fig. 1) is a rubber seal to function as an initial water management barrier.

If the vinyl is damaged when it is removed and it cannot be reused, please order replacement vinyl (LCI Part # 213162) online by visiting <https://store.lci1.com>.

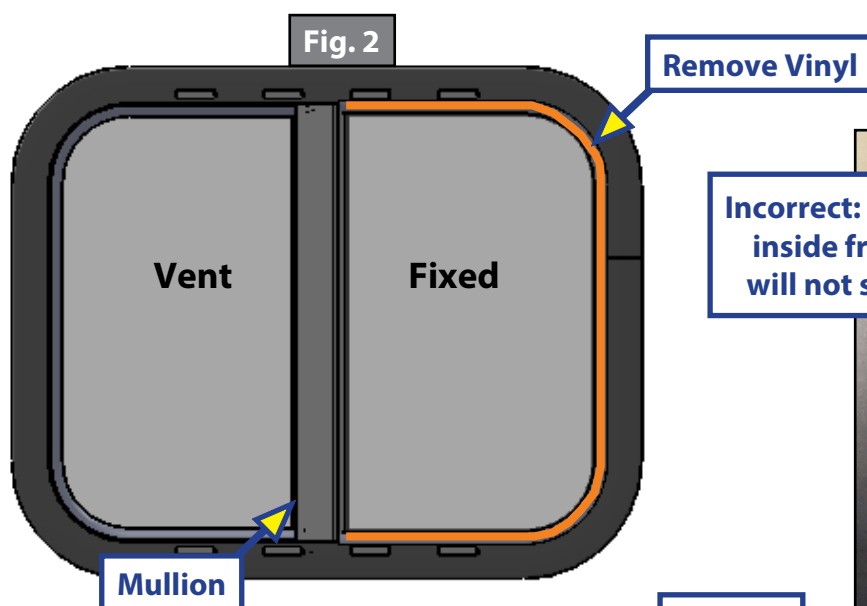
1. Pull out vinyl located around the outer perimeter of the fixed glass (Fig. 2) and save for reuse in areas not covered by a glazing bar.

**NOTE:** Do not remove vinyl on the mullion side of the glass (Fig. 2).

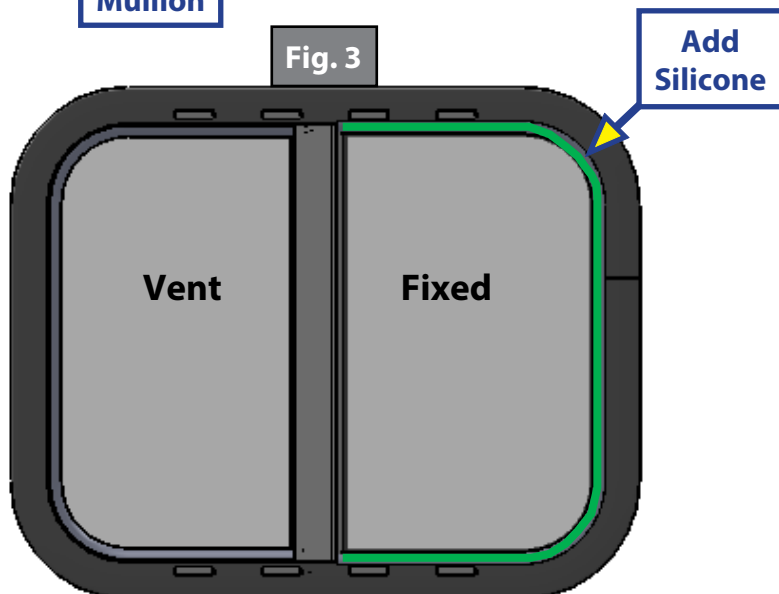
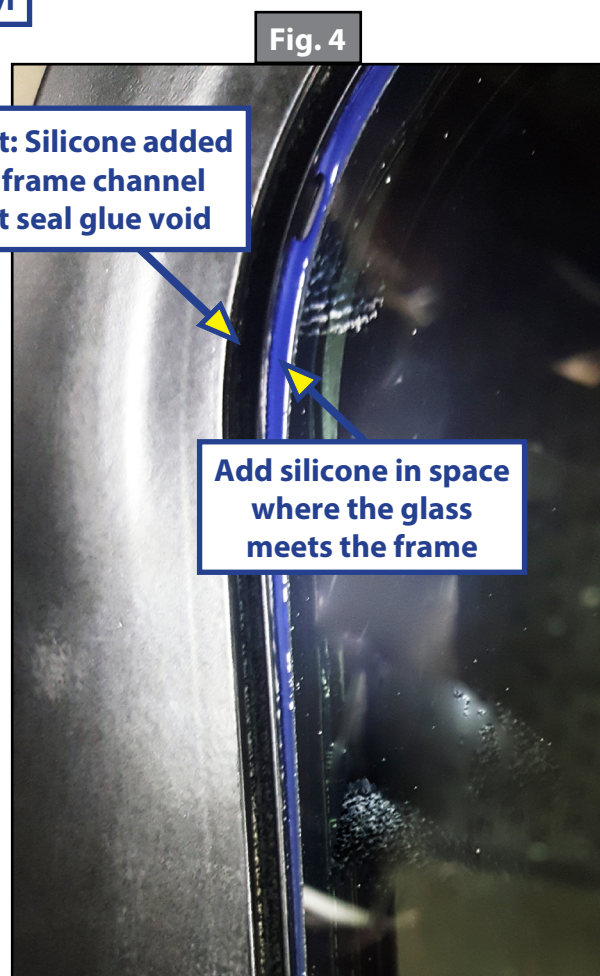
2. Run a bead of 100 percent silicone around the outer perimeter of the fixed glass (Figs. 3 and 4).
3. Reinstall the vinyl that was removed.

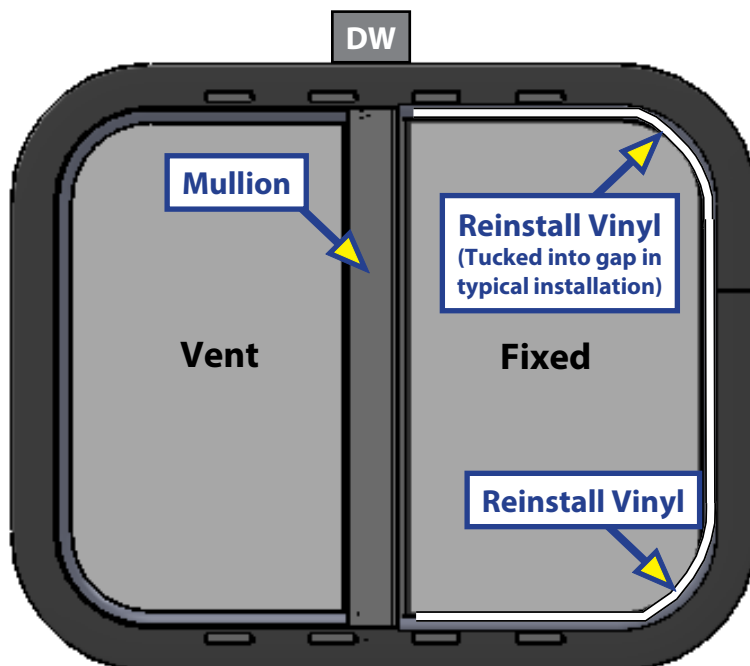
| 8800 Series DW (Dual Weep) |

**NOTE:** Please utilize this table to verify sizes affected of the style window shown above.

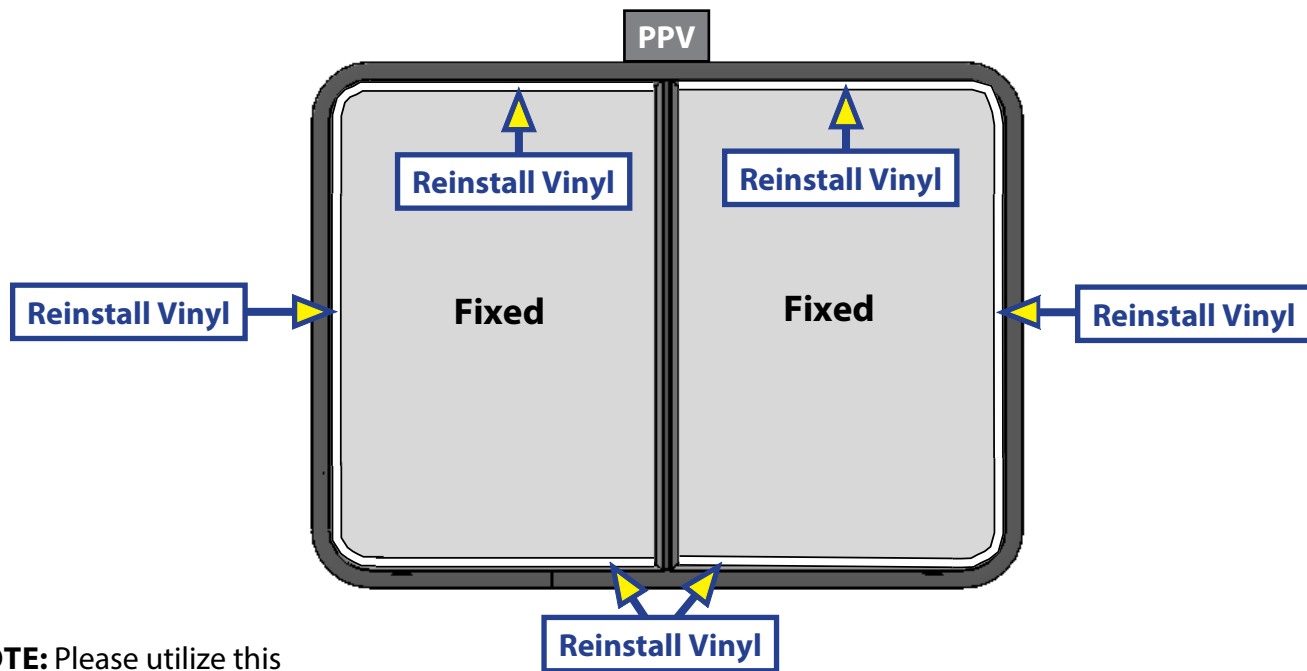
8800 Series PPV (Picture Picture Vertical)

**NOTE:** Please utilize this table to verify size affected of the style window shown above.

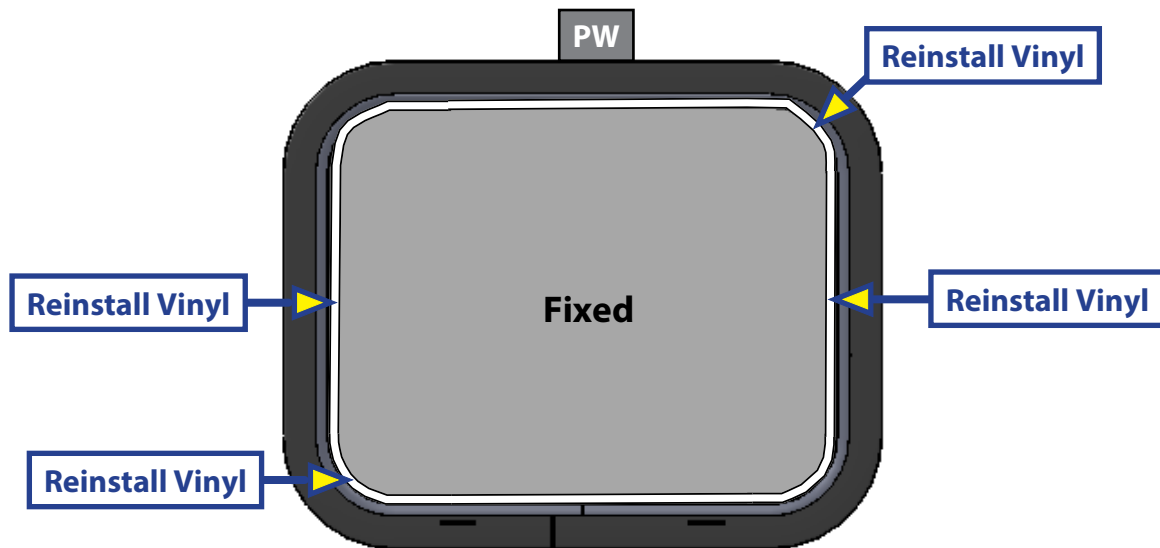
8800 Series PW (Picture Window)

**NOTE:** Please utilize this table to verify sizes affected of the style window shown above.

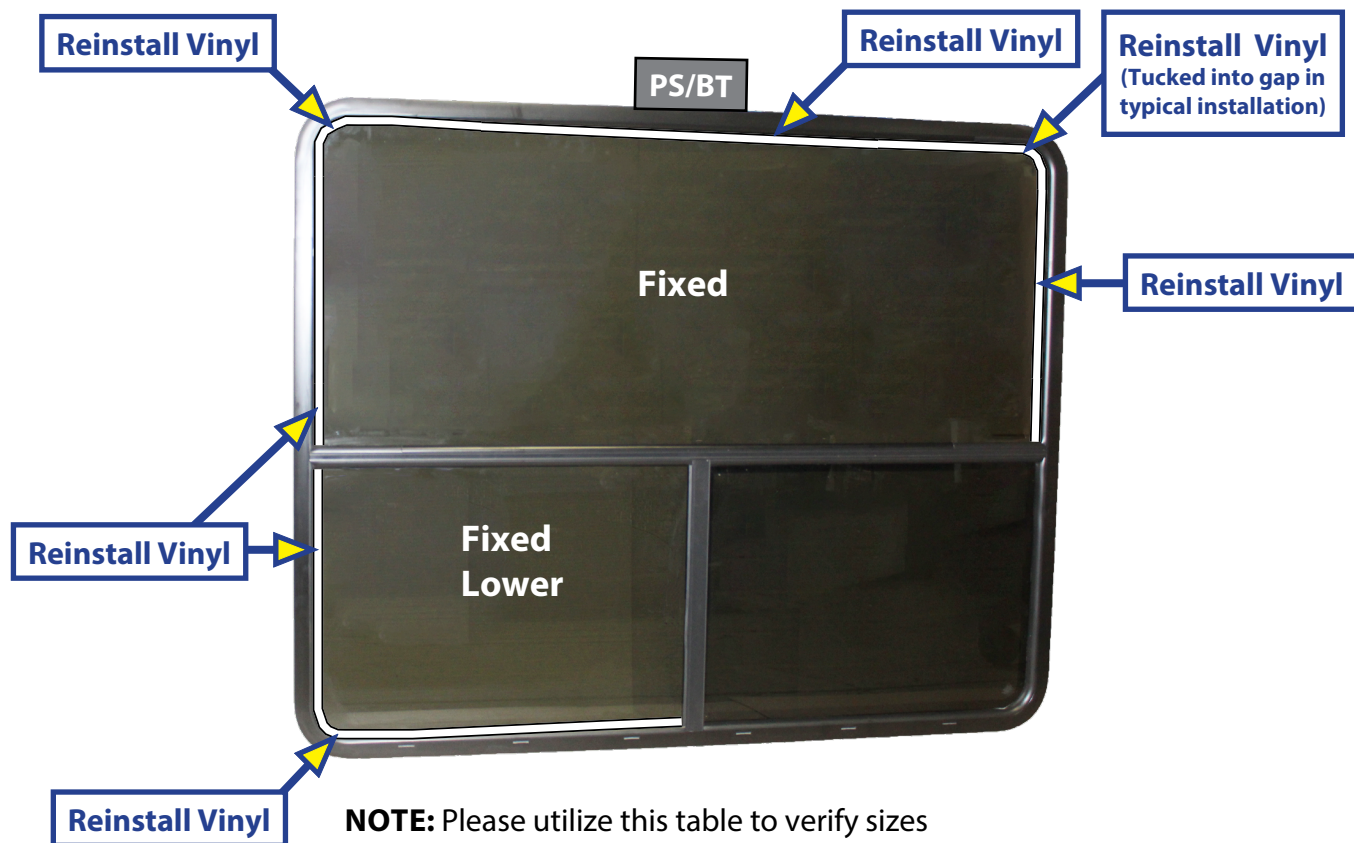
| PS/BT (Picture Slider Bottom T) |

**NOTE:** Please utilize this table to verify sizes affected of the style window shown above.

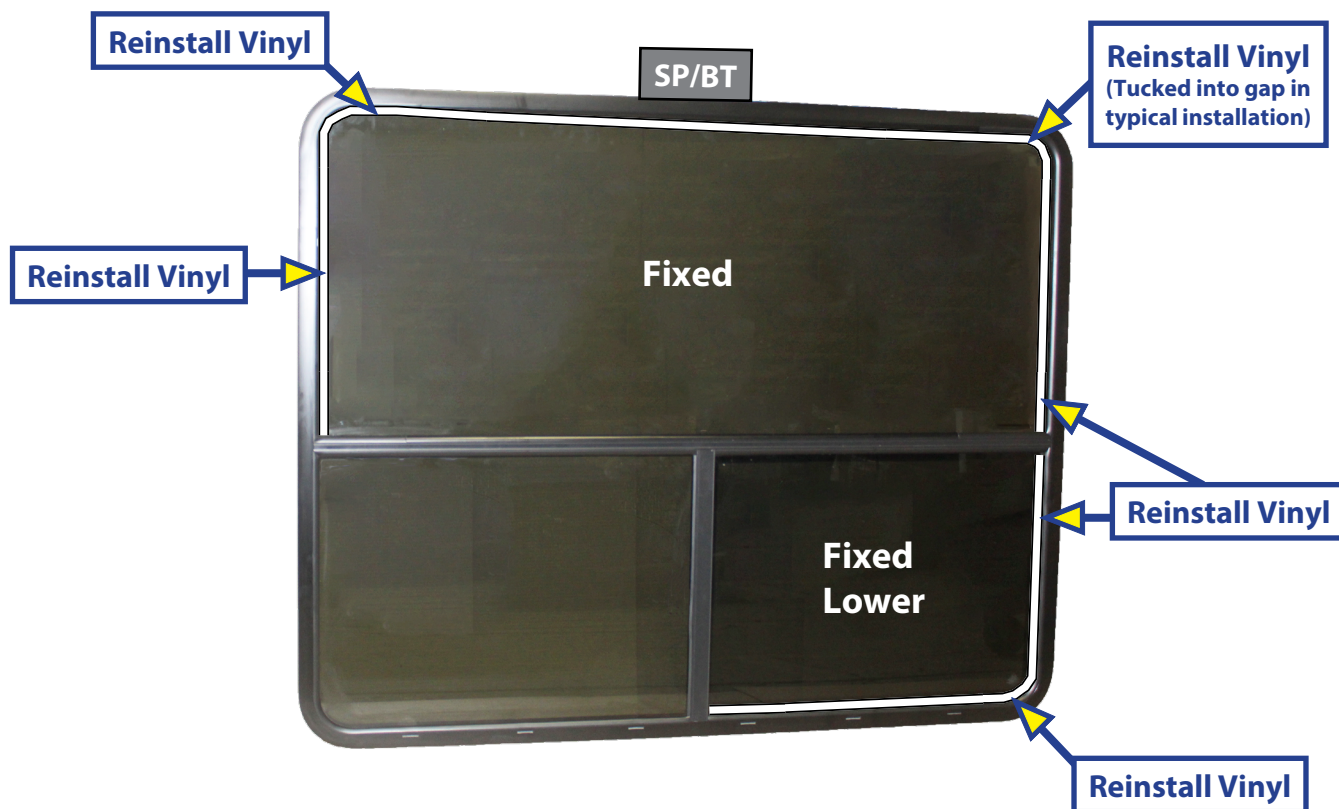
| SP/BT (Slider Picture Bottom T) |

**NOTE:** Please utilize this table to verify sizes affected of the style window shown above.

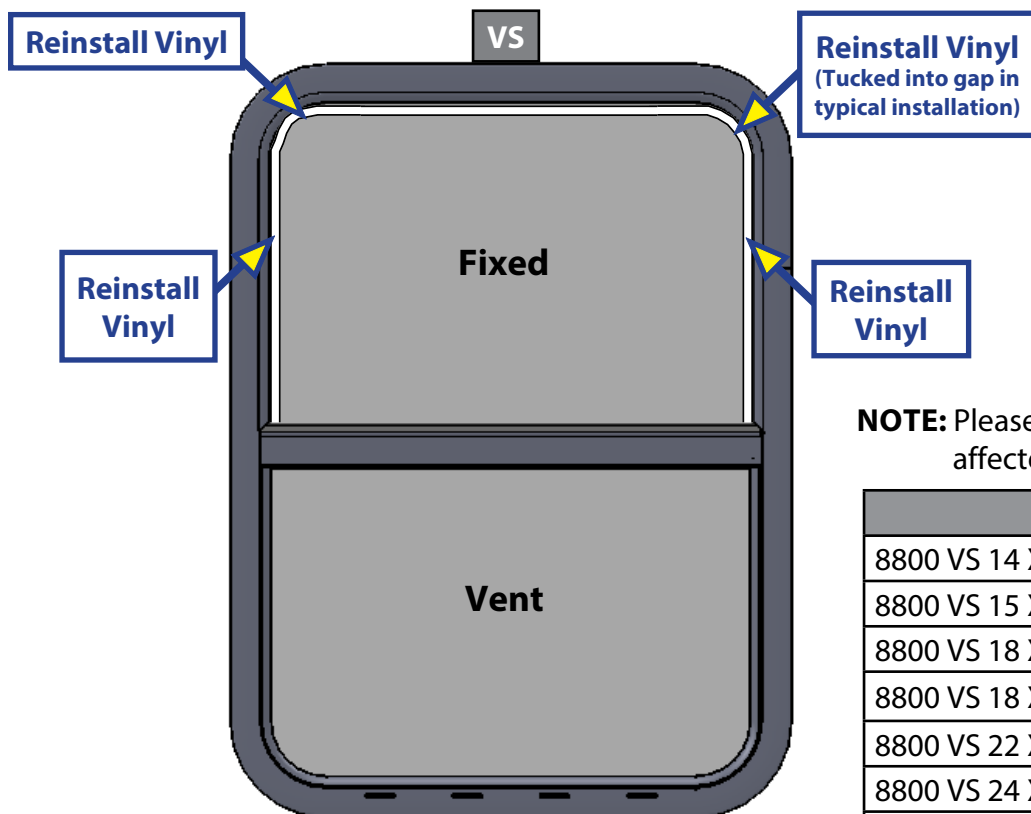
| VS (Vertical Slider) |

**NOTE:** Please utilize this table to verify sizes affected of the style window shown.
