# EUROLOFT™ BED LIFT MOTOR REPLACEMENT

| TSB Number: | 20E-074 |
| Product: | EuroLoft™ Bed Lift Motor |

Select motors (PN 346074) received from an LCI supplier have the potential for primary gear failure, allowing for the possibility of the bed frame to drop a short distance before the safety strap catches the bed frame assembly. This document will describe the process of removing a defective motor and replacing it with a new motor.

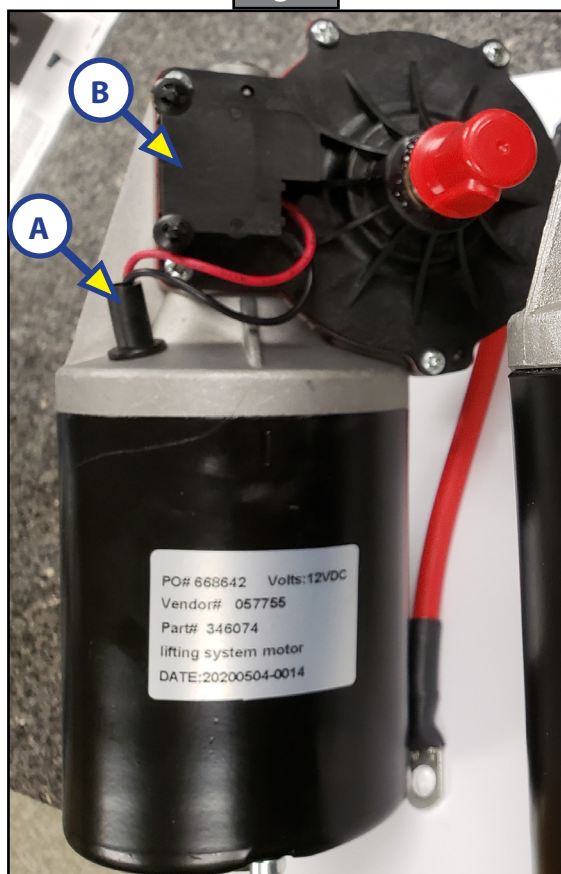
Fig. 1

**NOTE:** OLD defective motors (Fig.1) have red and black wires (Fig.1A) exiting the motor, and no LCI logo on the plastic casing of the gear box cover (Fig.1B). NEW replacement motors (Fig.2) will have green and black wires (Fig.2A) exiting the motor, and a molded LCI logo on the plastic gear box cover (Fig.2B).
