# **T.I.P. Troubleshooting Information on Power Gear**

## **Inner Rail Realignment**

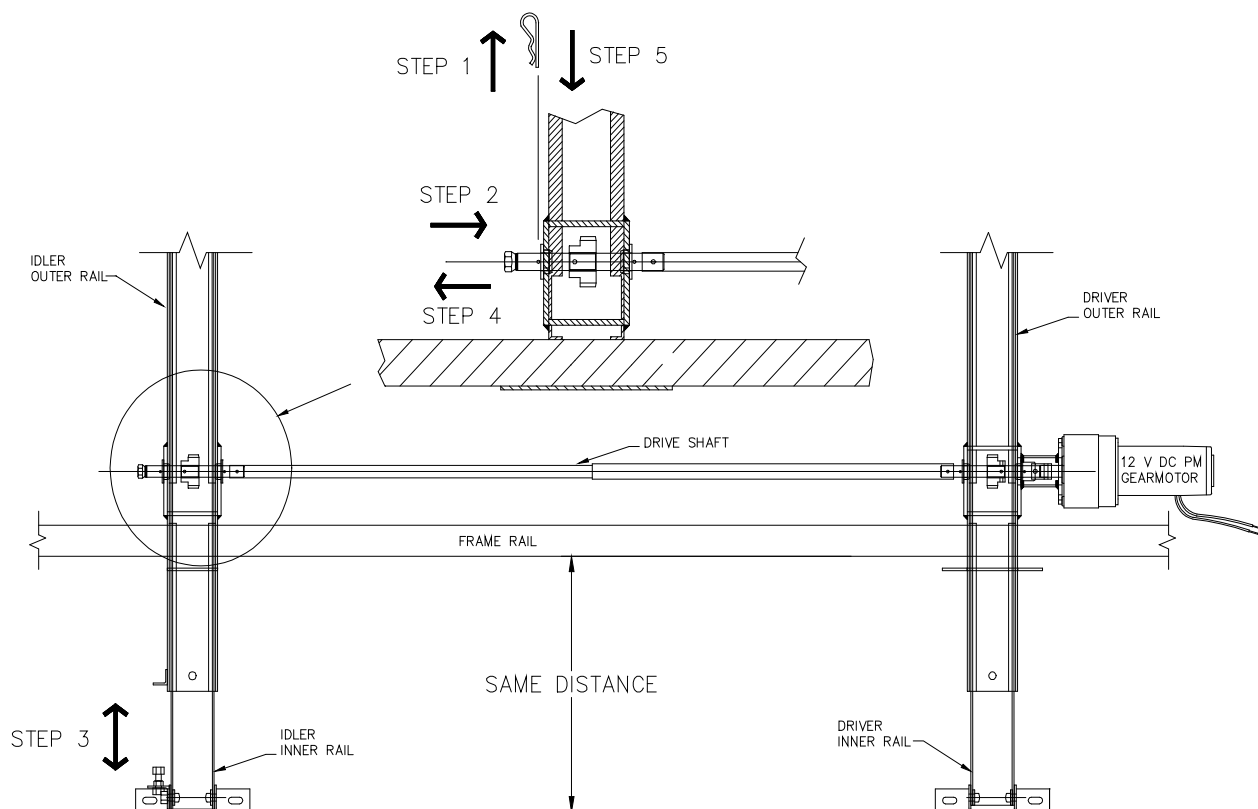
1. Remove cotter hairpin from idler drive shaft.
2. Push the idler drive shaft toward inner rail to disengage the gear from the gear rack.
3. Adjust the room by sliding the idler rail side of the room to the proper position (same distance from the frame as the drive rail side).
4. Push the idler drive shaft back into position engaging the gear and the gear rack.
5. Reinstall cotter hairpin in idler drive shaft.
6. Extend and retract room a couple of times and check for proper room flange sealing.
7. If room is not aligned properly, repeat steps 1 thru 6.
