| TSB Number: | 01-002-18D |
| Product: | Solera® Awning Smart Arm |

Sealant correction to mitigate moisture in the Solera® Awning Smart Arm wiring harness splice lines.

This bulletin involves adding liquid tape sealer around the shrink tubing to block leak paths.

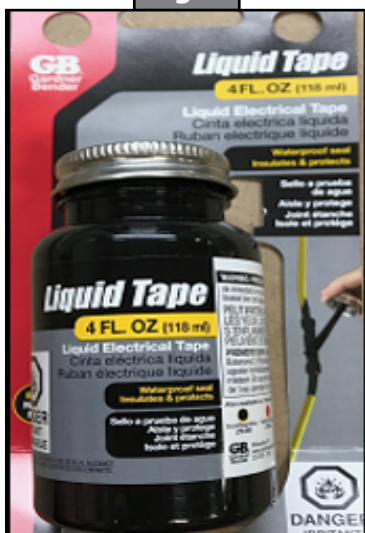
Fig. 2

- Scissors or utility knife—electrical tape removal
- Blunt-edged tool—RTV silicone removal
- A quick-curing liquid tape sealer intended for outdoor use that is not silicone or gel/paste material. LCI recommends using one of the sealants shown below (Figs. 2 and 3).

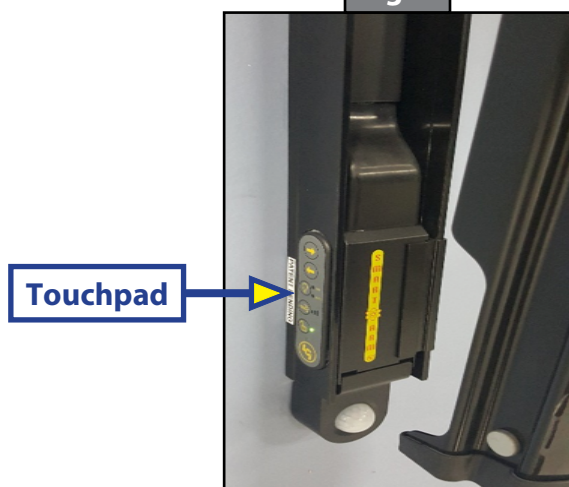
Fig. 4

1. Open the awning arm to access the Solera Smart Arm touchpad (Fig. 4).
2. Slide the wire cover up (Fig. 5A), then pull outward to remove.
3. Remove the connector small wire cover (Fig. 5B).

6. Complete a full inspection of the touchpad (Fig. 4) and the wire harness (Fig. 5) before starting the sealing process. If no corrosion or damage is noted, go to step 10.

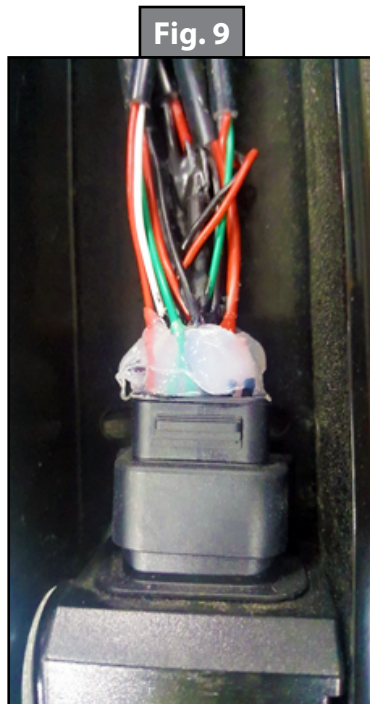
11. Remove any material from the topside of the connector that would prevent access to the splice lines requiring sealing. Depending on manufacture date, the topside of the connector may have RTV silicone (Fig. 9) or electrical tape (Fig. 10).

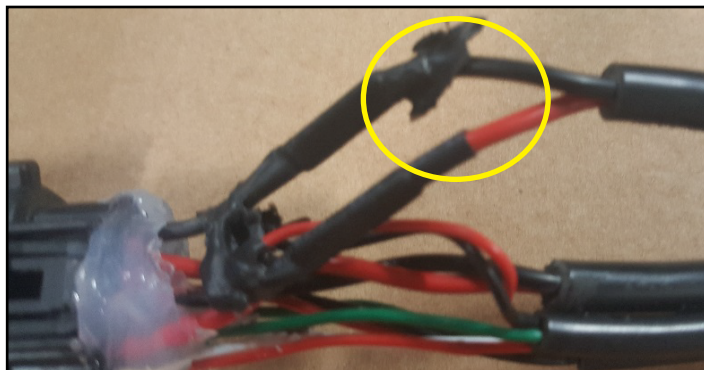
Adjacent wires came into contact with the ground wire application before curing, making the seal ineffective.
