# Service Bulletin

82-S0515

## Room Slide Control Replacement (Installation Instructions)

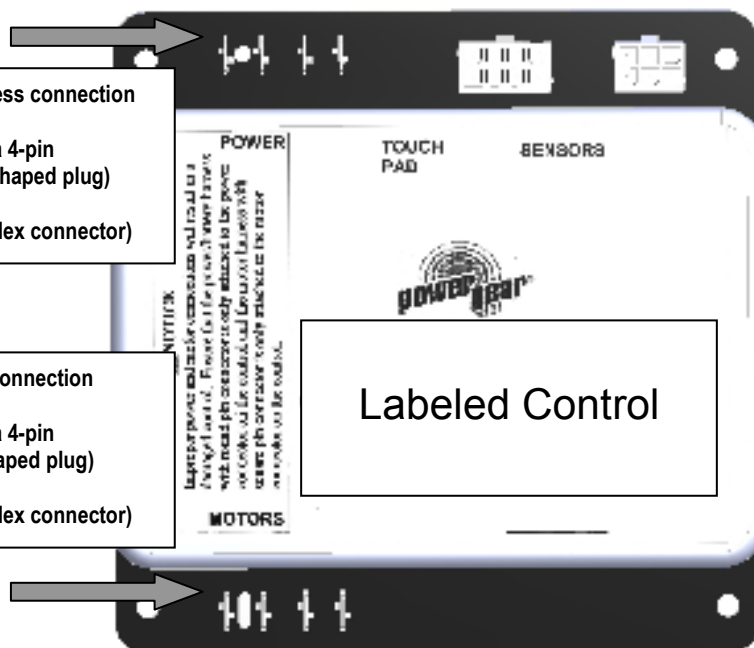
The battery (power) and motor harness receiving hole connection points (located between the 1<sup>st</sup> and 2<sup>nd</sup> blade connectors) are identified on the decal located on the control to ensure proper installation.

### Battery (power) harness connection

(MY'09 and prior uses a 4-pin connector with round shaped plug)

(MY'10 uses a 4-pin Molex connector)

### Motor Harness Connection

(MY'09 and prior uses a 4-pin connector with oval shaped plug)

(MY'10 uses a 5-pin Molex connector)

For ease of installation, and to ensure proper connection, replace one harness at a time.
