# Winegard Trav'ler Antenna Troubleshooter

## No LNB Voltage-SWM3

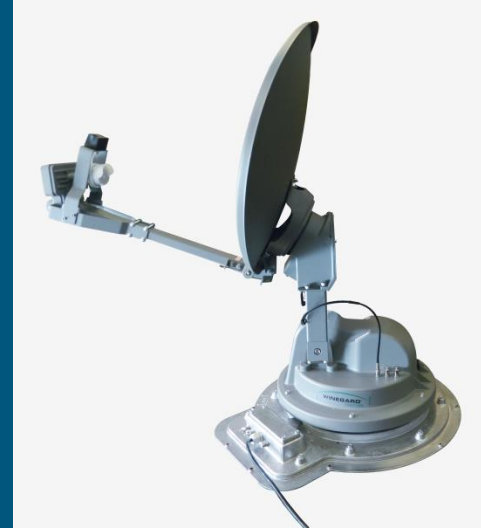
To begin the antenna must be in the up position, power the interface box on, when the antenna raises up so the arm is at least parallel to the roof, see the picture to the right for reference. Press and hold power and select on the interface box to power the box off without stowing the antenna. Now it is time to get on the roof with the coax cable and tools.

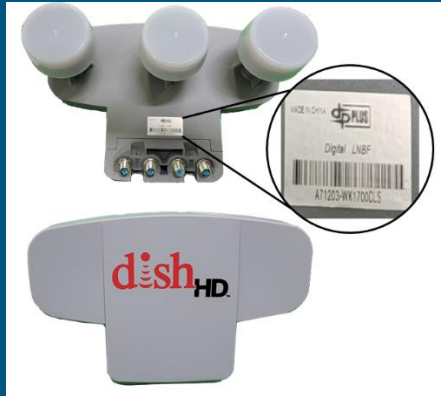
DISH Pro Plus

Use these images to help determine your LNB type then select the appropriate option below.

Dish Pro Plus(DPP)

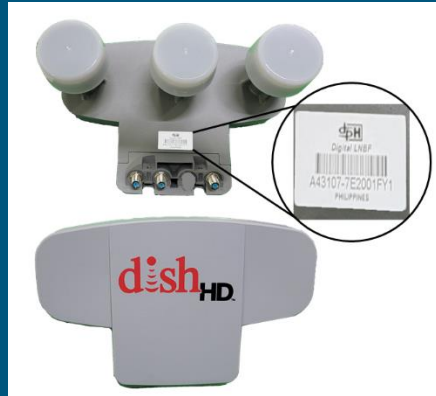
Dish Pro Hybrid(DPH)

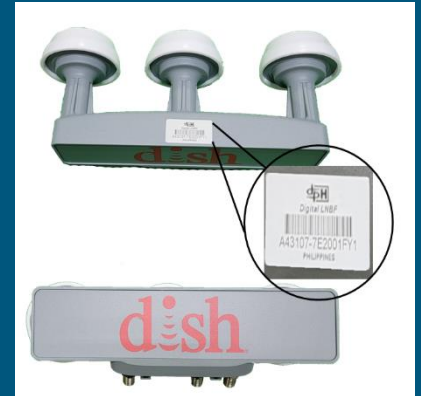
DISH Pro Hybrid

Dish Pro Hybrid(DPH)  
Slimline

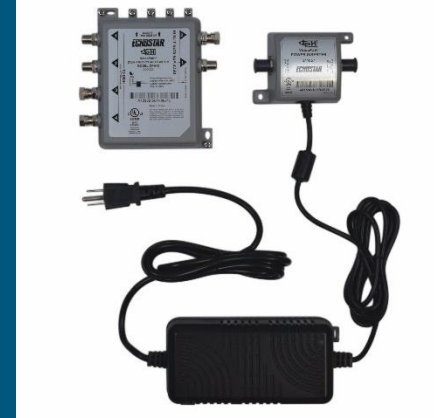
[DPH42 Switch Kit](#)

In order to use a Hopper 3 with a Trav'ler DISH Pro Plus LNB system, a DPH42 kit is required. See image to the right. If you do not have this kit you can purchase it on our website. If you already have this kit and it is installed as outlined in the manual click the Next button to proceed.

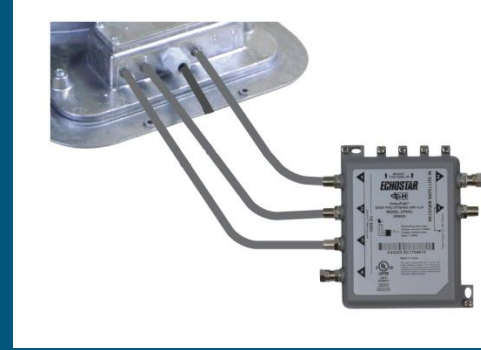
If you are missing satellites, locate three cables going into the satellite ports on the DPH42 switch. Swap the cables going to ports 1 and 2, if there is no signal change swap the cables going to ports 2 and 3.

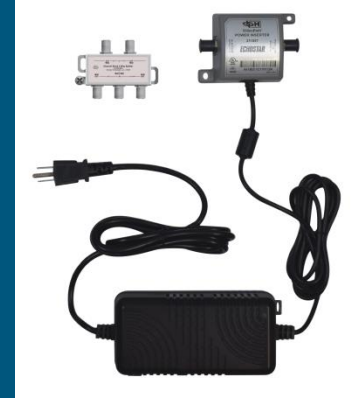
If you are using a single Wally receiver it is recommended to connect it to port C at the base of the antenna. If you are using multiple Wally receiver a Channel Stack splitter kit is required. See image to the right for that kit. If you do not have this kit installed it would need to be purchased and installed before troubleshooting can be done.

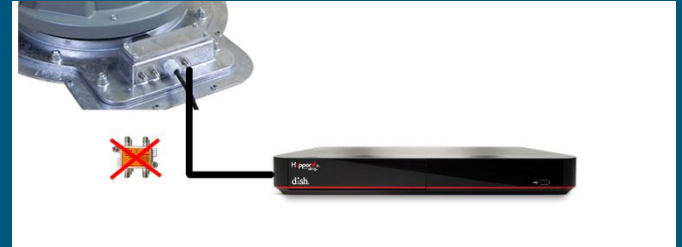
Bypass the Hybrid Solo Hub if in use.

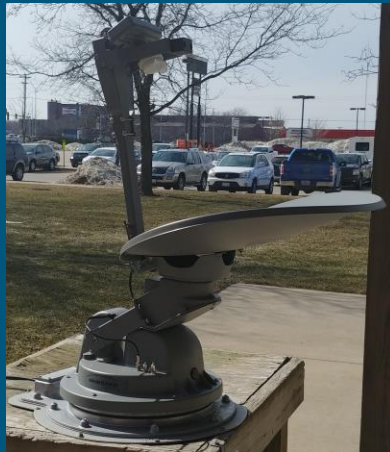
When it says Calibrate EL Success, press enter.
