# Winegard WiFi/4G Antenna Troubleshooting

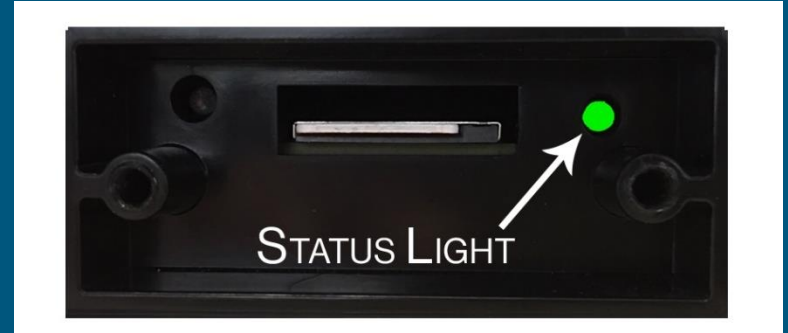
Troubleshooting power with the Connect 2.0 requires getting on the roof. At the base of the antenna you will find a clear plastic, removable using a phillips screw driver. Under that plate is a status light. With the system powered on is that light lit.

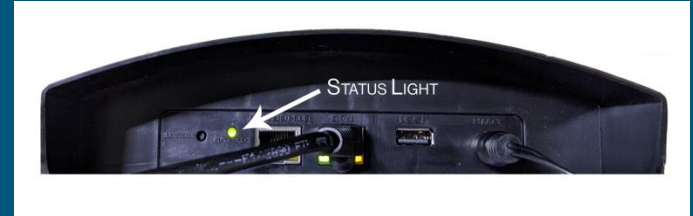
Begin by locating the indoor device, verify the power cord is plugged into the unit and a wall outlet. Locate the status light shown in the image to the right.

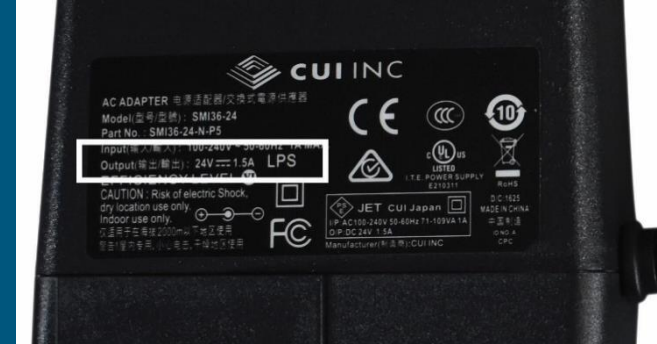
If the status light is not lit, unplug the power adapter from the wall. Check the label and compare it the image to the right. The adapter should have a 24vdc and 1.5amp/1.67amp output.

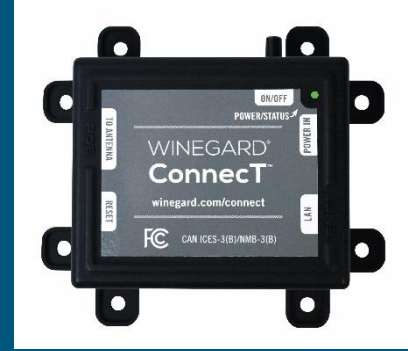
Locate the status light on the indoor power inserter assembly. When the power button is depressed this light should be lit. See image to the right.

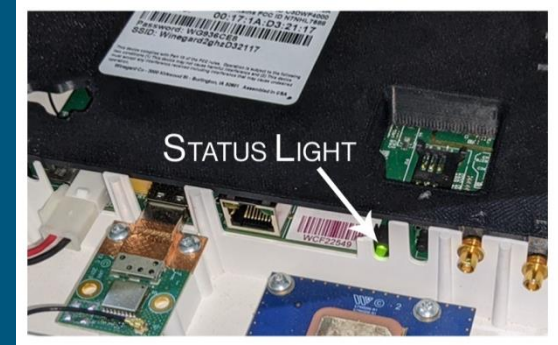
If the Gateway is not broadcasting its SSID, make sure the device is powered on, and check the status light on the back of the Gateway.

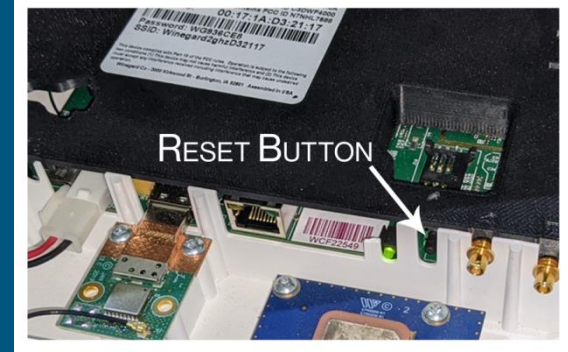
With the status light lit, hold the reset button next to the status light for a full 180 seconds to reset the system.

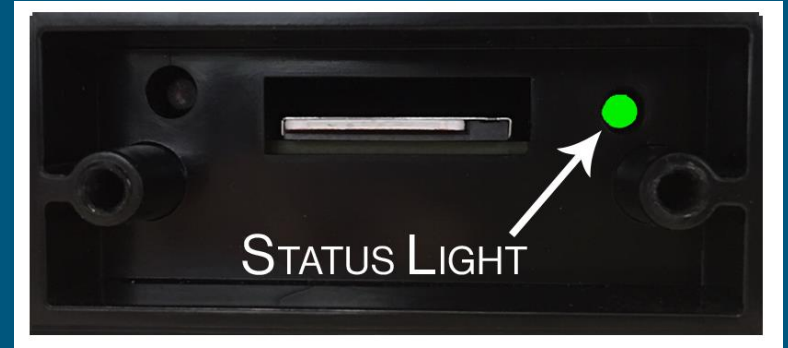
Troubleshooting No SSID with the ConnectT 2.0 requires getting on the roof. At the base of the antenna you will find a clear plastic, removable using a phillips screw driver. Under that plate is a status light. With the system powered on is that light lit.

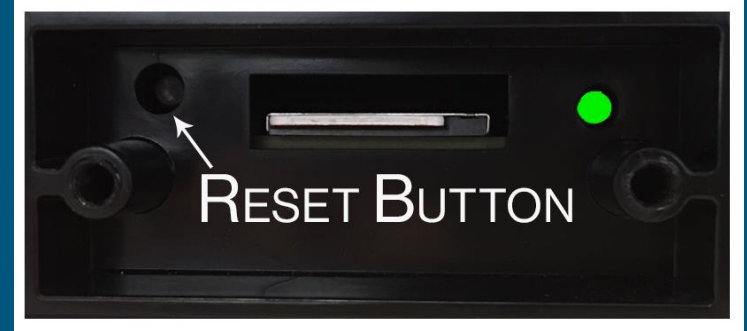
With the status light lit, press and hold the reset button for a full 180 seconds to reset the system.

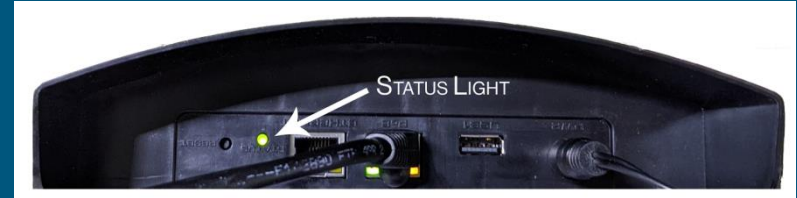
To troubleshoot a NO SSID with a 1<sup>st</sup> Gen Connect with IDU make sure the power adapter is plugged into the back of the IDU, and the wall outlet. Locate the status light, see image to the right.

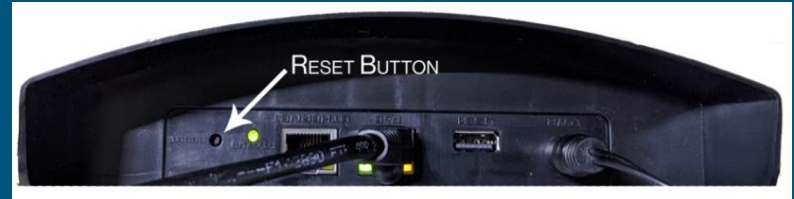
With the status light lit, press and hold the reset button for a full 180 seconds to reset the system.

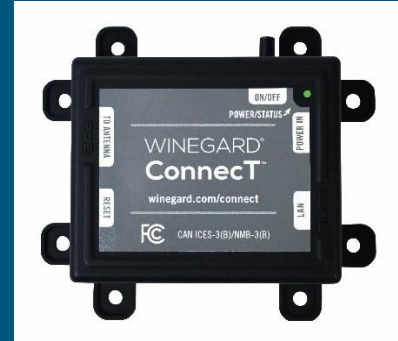
To troubleshoot a NO SSID with a 1<sup>st</sup> Gen Connect with POE make sure the power cable is plugged into the POE and the POE is turned on. Locate the status light, see image to the right.

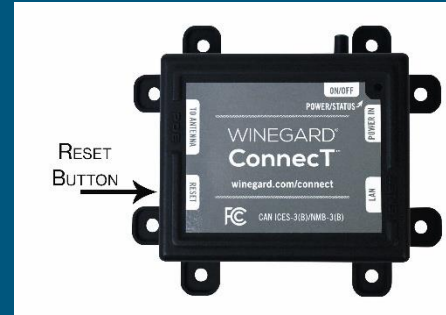
With the status light lit, press and hold the reset button for a full 180 seconds to reset the system.

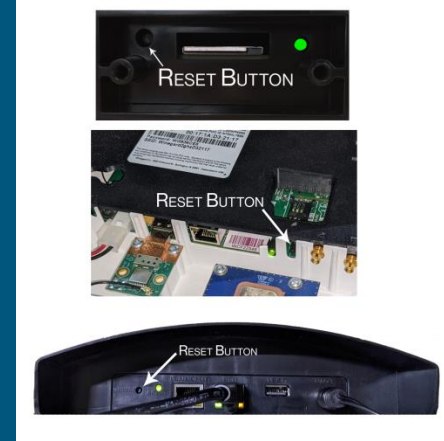
If the page does not load a system reset would need to be done. Using the image to the right locate the reset button on your system. Hold the reset button for a full 180 seconds to reset the system, then try and access the interface again. If you continue to experience issues please contact Winegard Customer Support via phone at 800-288-8094, or email [help@winegard.com](mailto:help@winegard.com).

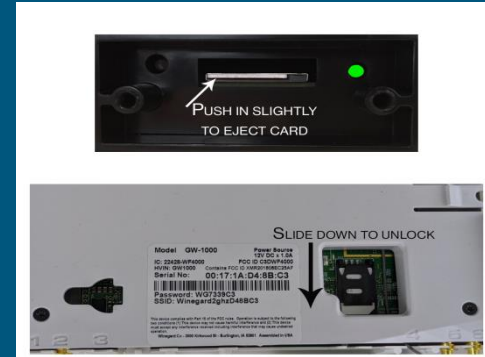
2. If your system has a removable SIM card, power the system off, remove the SIM card, clean the copper contacts with a pencil eraser if available, or wipe it with your finger and replace the SIM card. DO NOT use any liquid to clean the SIM card contacts. See the image to the right for SIM card locations.
