1. Run the room out (Extend) all the way. When working with one side, it is not necessary to place any support under the room.
2. **Figure A.** Loosen both chain nuts on the side affected, counterclockwise, until there is 2" of thread showing on both studs. If more slack is needed, loosen the Cable Adjustment nuts seen in **Figure B.**
3. Remove the chain from around the sprocket on the gearbox.
4. Reposition the chain around the sprocket of the gearbox removing the slack in the chain. This will allow more adjustment at the bracket.
5. Tighten OUT cables until the room is sealed properly in the out position. (See full Adjustment Procedure.)
6. **Figure C.** Tension the IN cables to 1/2" deflection.
7. Fully retract the room to ensure that it seals in the IN position (RETRACT).
8. **Figure D.** Tighten all jamb nuts and replace foam anti-vibration blocks.

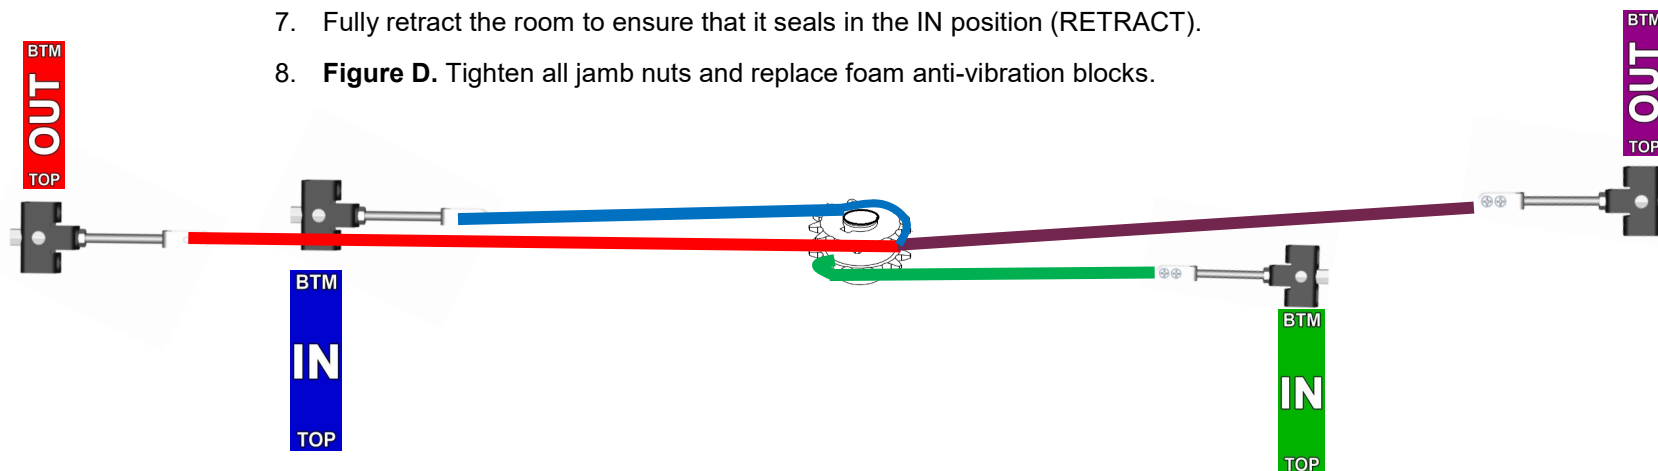
**Figure A.**

Chain Adjustment Nut

**Figure B.**

Cable Adjustment Nuts

**Figure C.**

**Correct Tension:** Push cable up or down 1/2"

**Figure D.**

Jamb Nut  
Anti-vibration blocks
