# **SERVICE MANUAL**

### **471X1A6565**

**Service Contact:**  
**Coast to Coast RV Services Pty Ltd.**  
**PO BOX 415**  
**REGENTS PARK DC NSW 2143 Australia**  
**Tel: +61-2-9645 7600**  
**[technical@coastrv.com.au](mailto:technical@coastrv.com.au)**

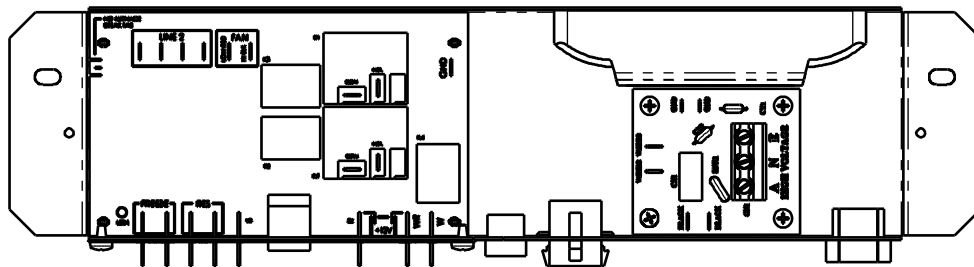
FIGURE 2

First, replace electronic board in ceiling assembly. If unit still does not operate, replace main control box (See Figure 2).

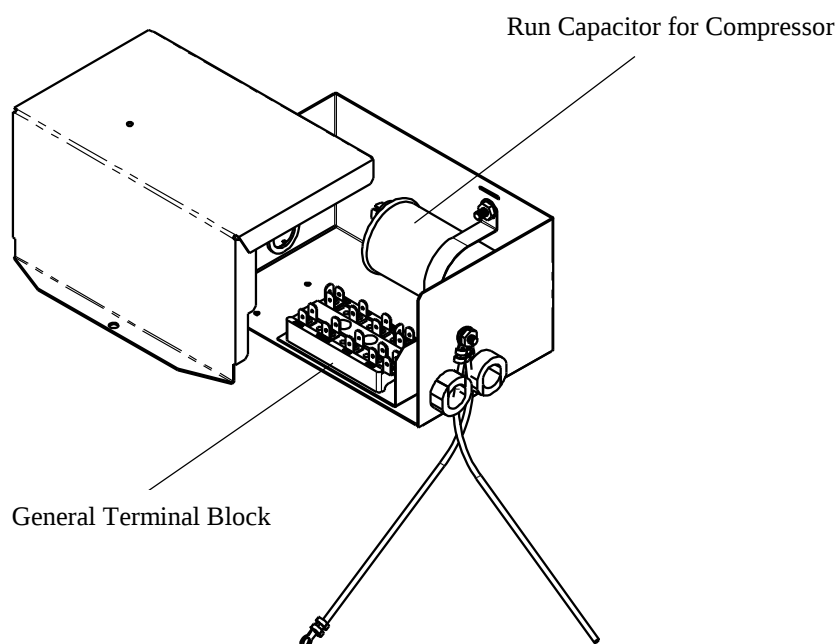
FIGURE 3

| <u>Likely Causes</u> | <u>Correction</u> |
|---|---|
| Run Capacitor | Check run capacitor inside of electrical box situated under condenser fan (See Figure 3). Replace if defective. |
