This document outlines the steps for replacing the foam tape on an 8800 series exit window.

# 8800 SERIES EXIT WINDOW FOAM TAPE REPLACEMENT

TI-332

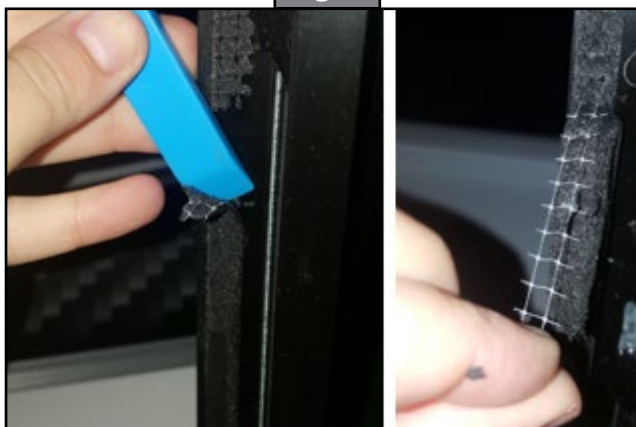
Fig. 3

**NOTE:** If the tape is difficult to remove, use a tool to peel up and grab the "string" within the foam tape (Fig. 3). This will help to remove the foam tape completely.

**NOTE:** Use a scraping tool to remove large excess foam tape from the frame surface. It is acceptable if a small amount of residual tape remains before the new tape is applied.

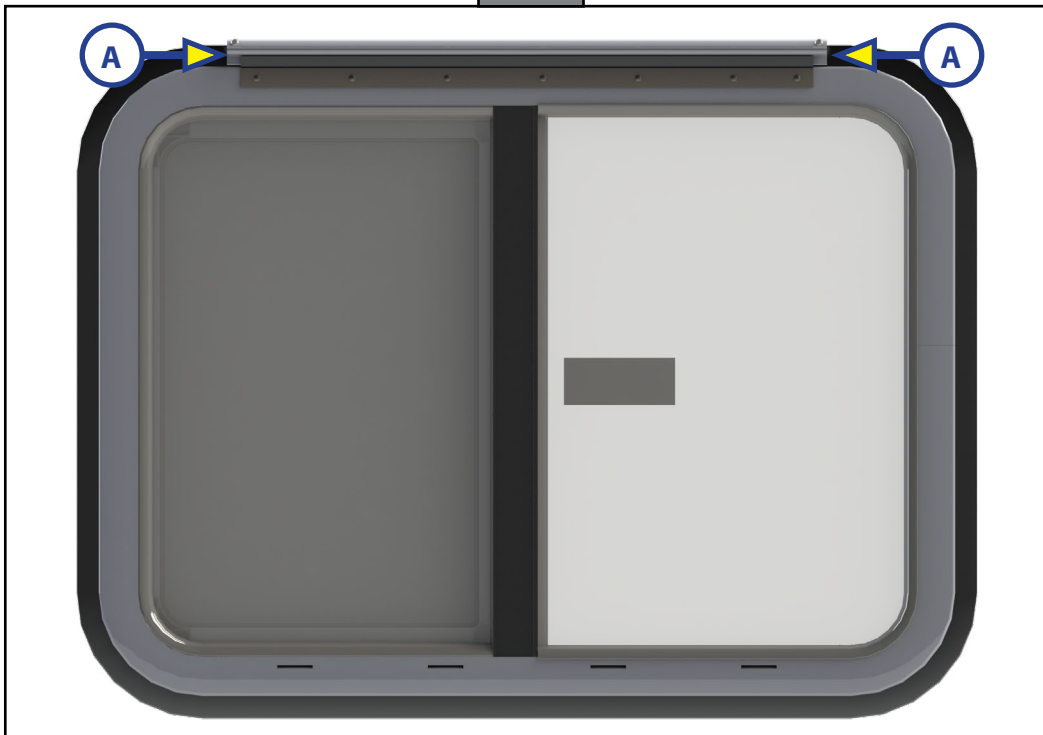
Fig. 6

8. Apply 100% silicone on the ends of the hinge (Fig. 6A) when the window is in the closed position.
