## AWNINGS

This document outlines the repair of awning fabric that has separated at the seam using Awning Seam Repair Adhesive PN 2022107896 (Fig. 1).

### Seam Separation Repair Procedure

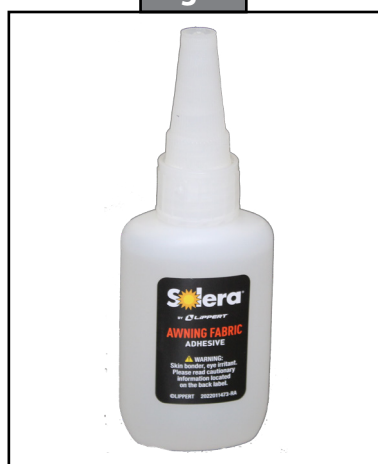
**Fig. 1**

**PN 2022107896****Safety****⚠ WARNING**

- Awning Seam Repair Adhesive PN 2022107896 (Fig. 1)
- Mild soap and water
- Ladder, if needed, to reach the awning rail or roll tube

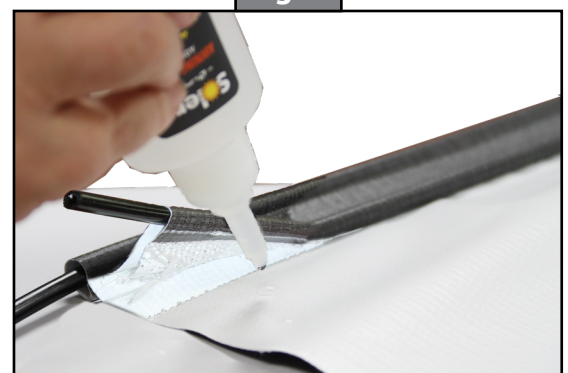
Fig. 3

1. Extend the awning:
  - A. For a seam fix at the awning rail, extend the awning a few feet.
  - B. For a seam fix at the roll tube, extend the awning completely.
2. Tie both awning arms slightly back to gain some slack in the fabric.
3. Clean the area to be repaired with mild soap and water. Allow to dry completely.
4. Spread open the seam area needed repair and apply a continuous bead of Awning Seam Repair Adhesive PN 2022107896 along the entire separation (Fig. 3).
5. Press down firmly and hold for several minutes.
6. Allow to dry for at least four hours.

**NOTE:** Photo shows fabric removed from the awning for clarity and upside down. The repair can be completed with the awning fabric installed.
