## Introduction

Heat Stain, also referred to as ghosting, heat rash or “skunk mark” is a tempering defect usually resulting from either dirty ceramic rollers in the tempering furnace, excessive heat in the tempering furnace or a combination of both. Heat Stain can happen in any type of modern tempering furnace but tends to be more prevalent in smaller oscillation (batch) furnaces where the glass oscillates forward and backwards before transferring as a batch to the quench.

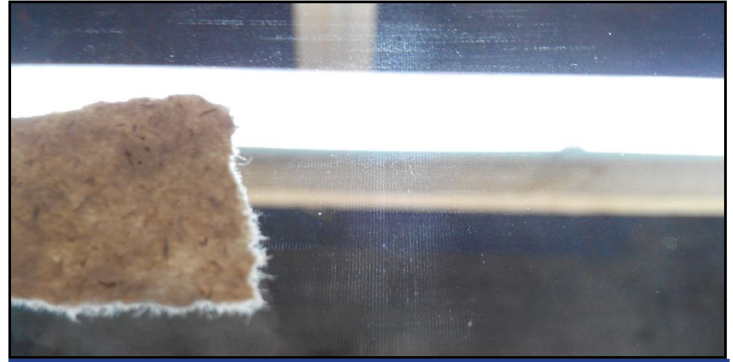
Magnified photo of Heat Staining on Clear Glass
