## SLIDE-OUTS

### Purpose

This document is for identifying the differences between the standard (Fig. 1) and inverted (Fig. 2) gear racks of an In-wall Slide-out system.

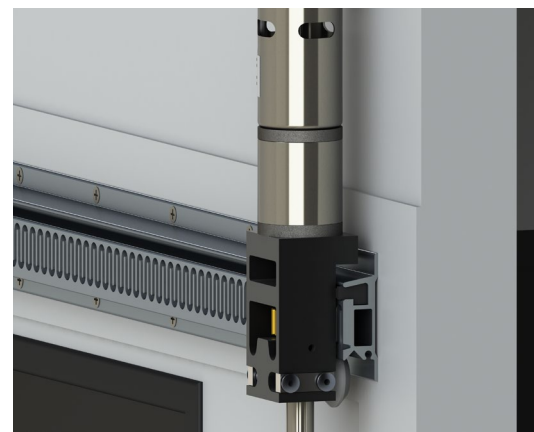
Fig. 1

#### Standard Gear Rack

Upper Rack

Lower Rack

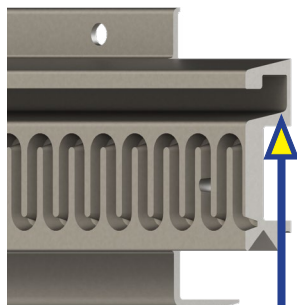
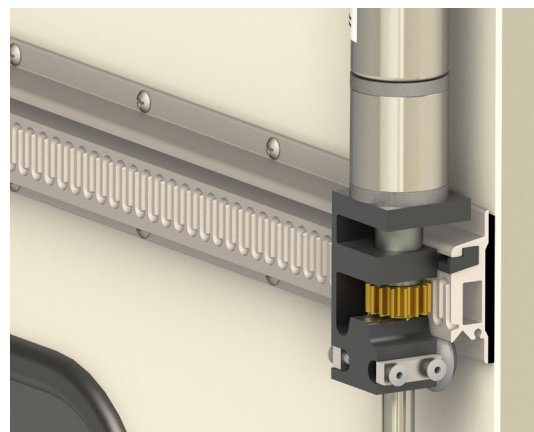
Fig. 2

#### Inverted Gear Rack

Upper Rack

Lower Rack

Inverted design allows for better water deflection.

**NOTE:** The assembly images on the right in Figures 1 and 2 are cut-out for clarity. The installed system will not have the same view.

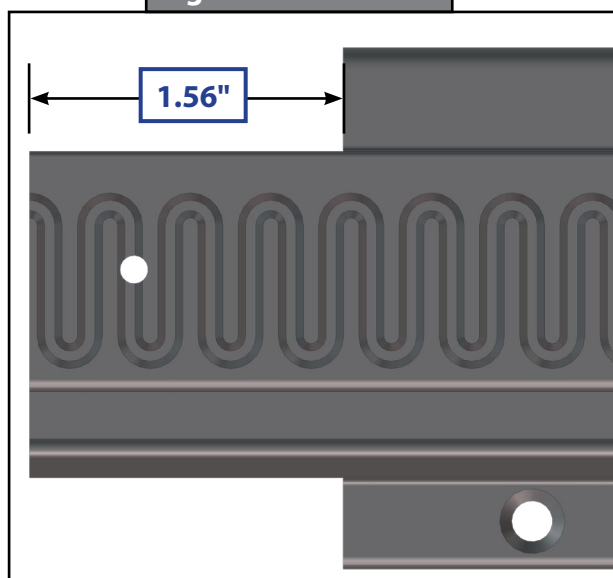
Fig. 3 - 1.56" Notch

#### Standard (w/ 1.56" Notch)

If the system being repaired has a different notch than the 1.56" described in Figure 3, use the images below to identify the notch, then contact LCI at (574) 537-8900 for ordering assistance.
