## DOORS

This document describes the procedure to replace the vertical mullion in the center of the screen door of an RV entry door.

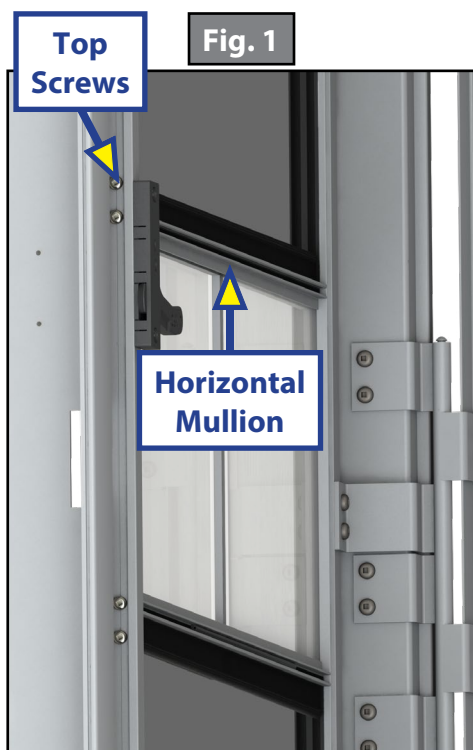
1. Remove both top screws on each side of the screen's horizontal mullion (Fig. 1).
2. Pull out enough of the screen spline in order to provide room to maneuver during the replacement procedure, about 4" past the vertical mullion (Fig. 2).
3. Pull out on vertical mullion to remove it (Fig. 2).

4. Install replacement vertical mullion by tapping it softly to seat it.
5. Replace the spline using a rubber mallet or a flat screwdriver and hammer to reinstall.
6. Reinstall the top horizontal mullion screws (Fig. 1) on both sides of the screen.
