# Tip Sheet #12002

## Pump Harness Fuse Update Spring Return Hydraulic Leveling

## Spring Return Hydraulic Leveling Pump Harness Fuse Update

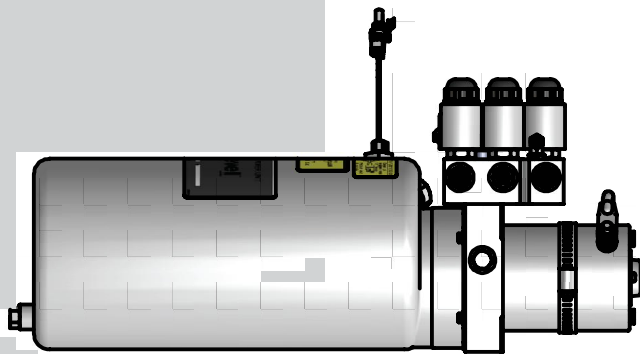
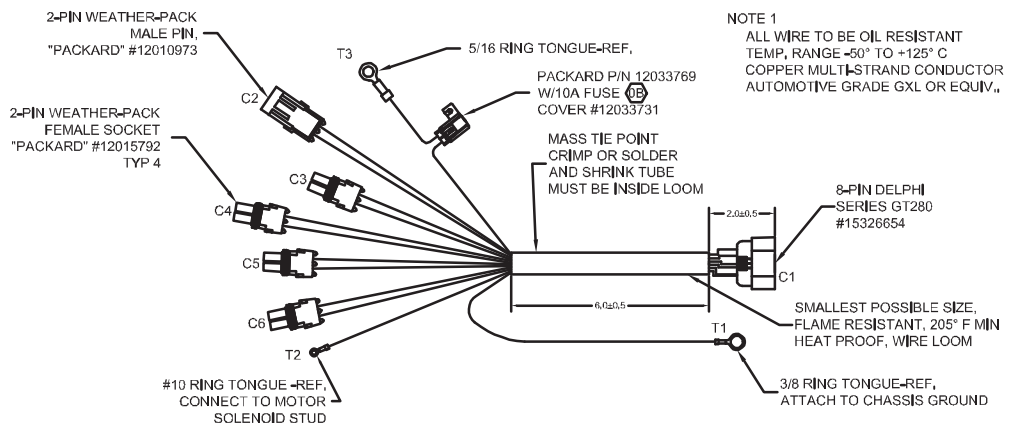
The fuse in the 1510000064 pump harness has been changed from a 5 amp to 10 amp fuse.

Condition: If, after attempting to operate the Power Gear Spring Return leveling system, the “Low Voltage” LED on the touch pad remains ON and no other buttons are functional, except on/off button, then the 5 amp pump harness fuse has blown.

Replace the fuse with a 10 amp mini fuse.

Winnebago Industries effected units were built/manufactured between June of 2007 through August of 2007. Units manufactured after that time period were equipped with the 10 amp fuse.
