## LEVELING AND STABILIZATION

This notice is sent to inform you of important product information concerning your motorhome. Lippert Components, Inc. is contacting owners of certain model year 2016-2019 diesel, Class A motorhomes manufactured through March 20, 2019 by REV Recreation Group, with Power Gear Power Up/Power Down leveling jacks.

The purpose of this document is to assist the coach owner inspect LCI/Power Gear Power Up/Power Down leveling jacks for common wear versus abnormal leakage.

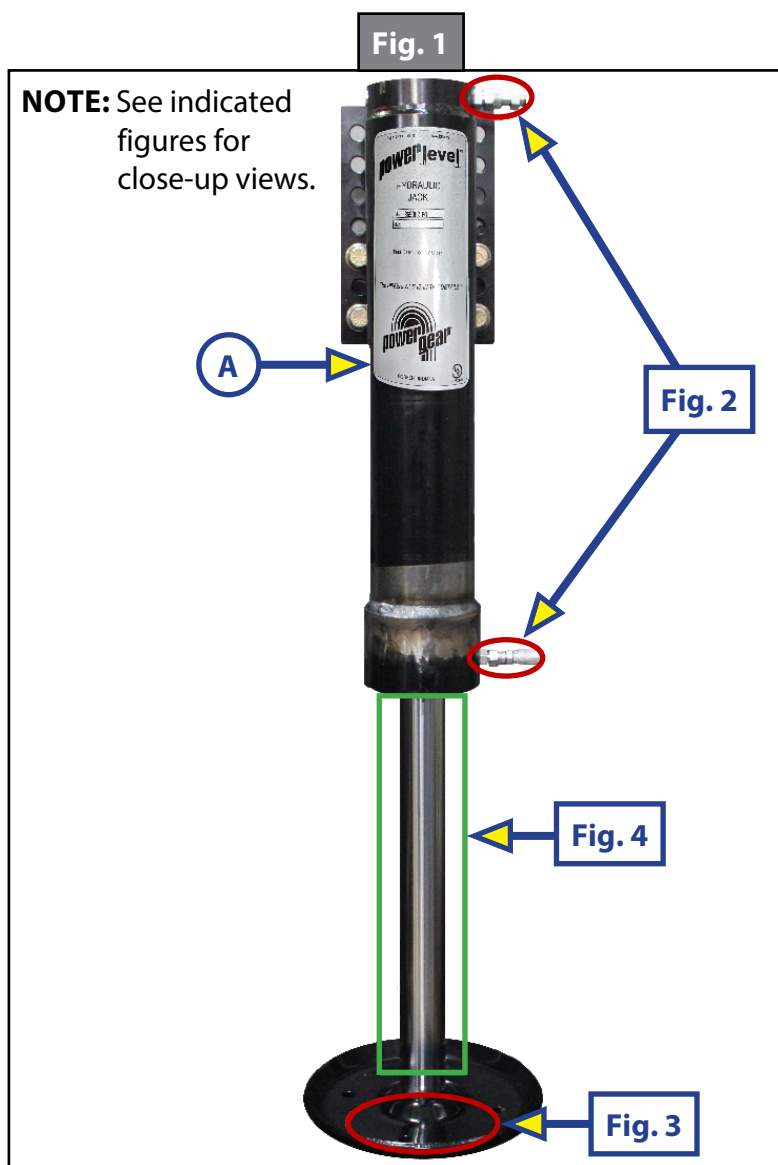
Visually inspect jack for external leakage (Fig. 1). For best results, run the auto-level and auto-retract sequence twice before performing visual inspection. If leaking persists, see the Action Needed section for information on ordering replacement jacks.

If there is clear evidence of a concern needing jack replacement, please contact your dealer to schedule an appointment.

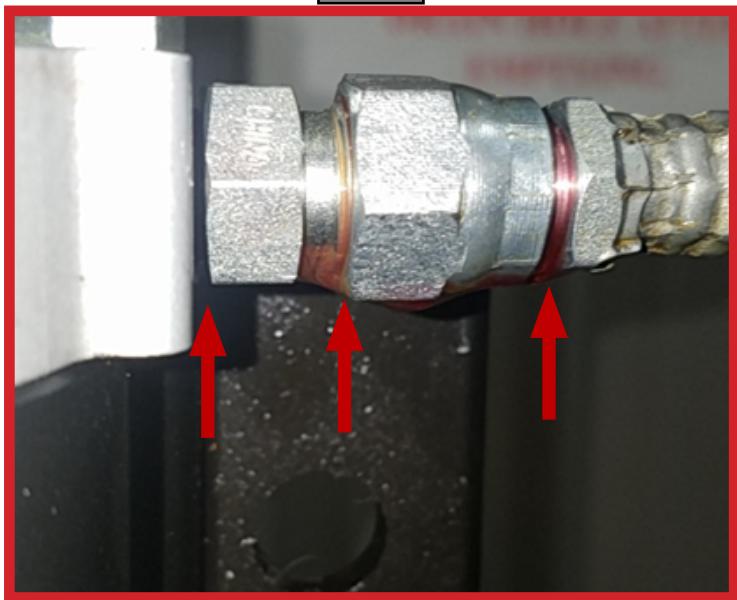
Fig. 2

Leaking fitting.

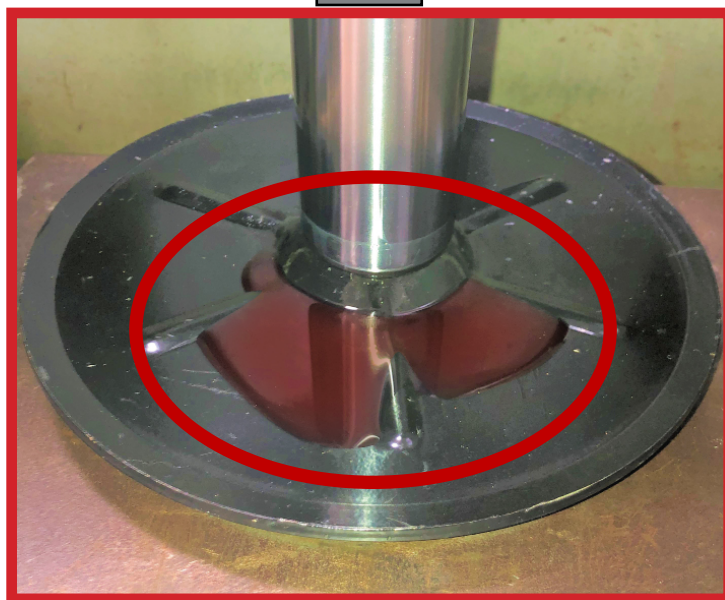
Fig. 3

Pooled fluid on footpad.

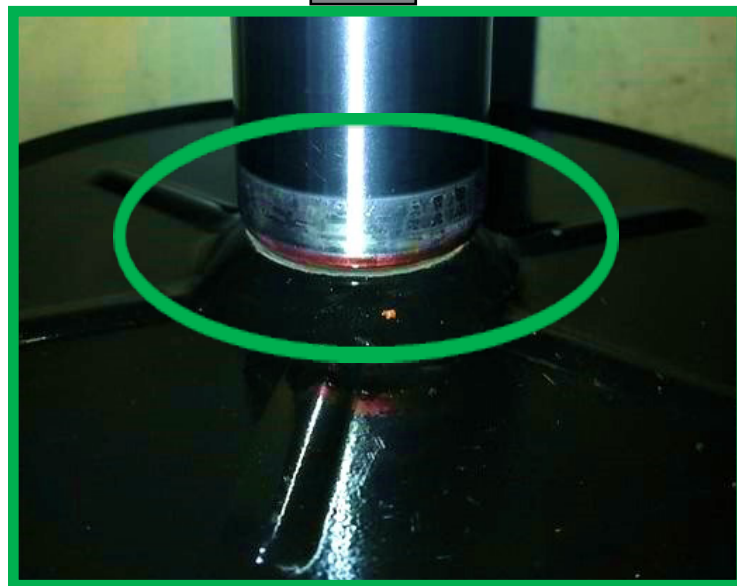
Fig. 4

A light oil ring on the rod at any jack position is normal and not considered to be a leak. No repair necessary.
