## DOORS

### Purpose

The purpose of this document is to describe the procedures to properly fix the window blind.

All T@B400 and T@B320 entry doors with following Lippert Italy Part Number:

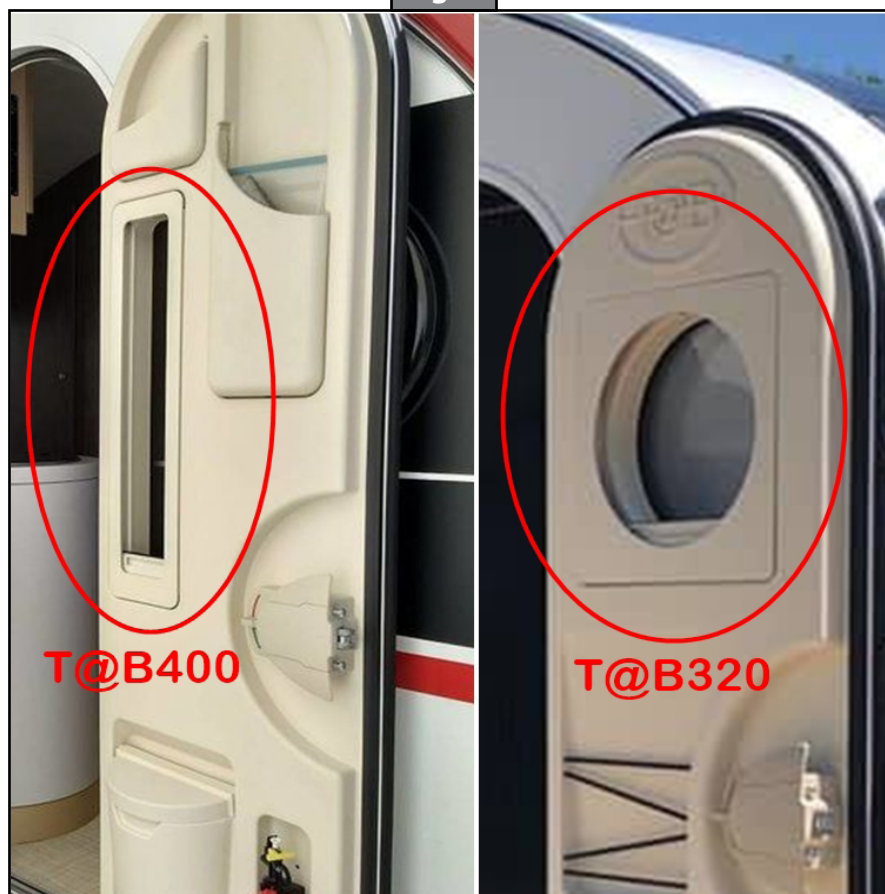
Fig. 1

**NOTE:** The only difference between T@B400 and T@B320 blinds is the shape (Fig. 1). The repair procedure is the same for both.

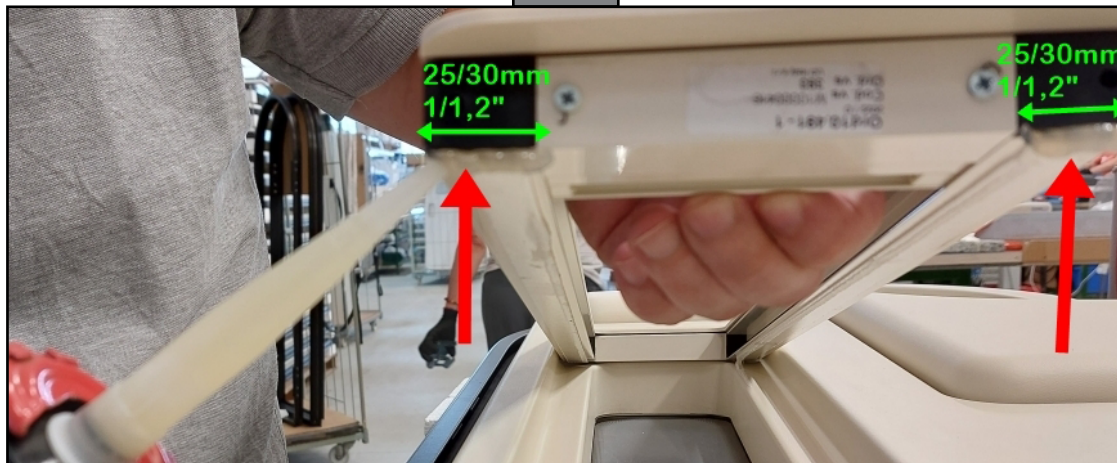
Fig. 7

Front View

1. Apply two strips of **Adhesive Sigill 779 Transparent** (Fig. 6) on the edges of the blinds as shown in Figures 7 and 8.
  - Strip Size: Width 6 mm (0.25")
  - Thickness: 4mm (0.16")
  - Length: 25 to 30mm ( 1.5")
  - Application Temperature: 5-40 °C (41-104 °F)

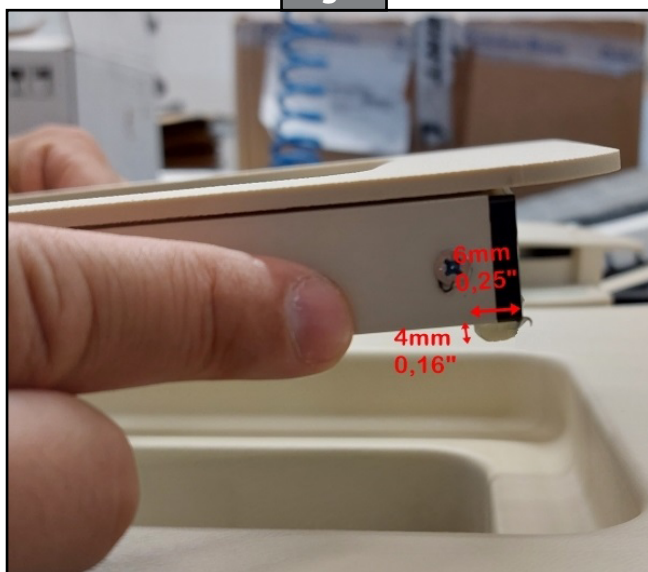
Fig. 8

Side View
