# INSPECTING MARINE SEATS FOR MANUFACTURER'S MARKINGS AND SEAT REPLACEMENT, IF NEEDED

| Recall Number: | USCG Recall 21MF0212 | | |
| Product: | Marine Seating | | |
| Date: | April 30, 2021 | Labor Rate Per Seat: | 0.2 Hours Inspection/0.5 Hours Replacement |

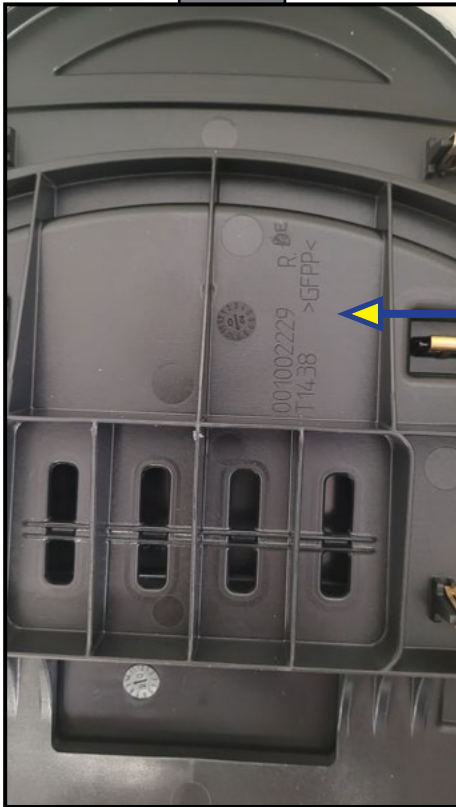
**Fig. 6**

- A. If molded information is on the seat back (Fig. 6) AND on the bottom of the seat as previously inspected, the seat is good and does not need replaced.
  - B. If NO molded information is on the seat back, (Fig. 7) the seat MUST be replaced.
2. Replace seat back cushion by aligning the cushion to the opening and snapping it back in place.

**Molded  
Markings**
