# **T.I.P. Troubleshooting Information on Power Gear**

## **FUSE REPLACEMENT FOR 500457 CONTROL BOX.**

NOTE: THIS IS FOR R.V.'S MANUFACTURED AFTER 8-1-98.

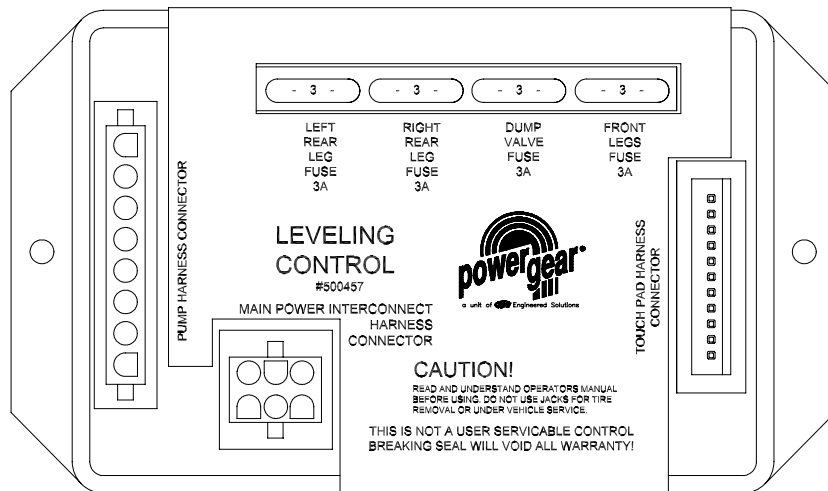
Part # 500457

ALL FUSES USED IN THE 500457 CONTROL BOX ARE AUTOMOTIVE 3 AMP, 32 VOLT, VIOLET COLORED FAST ACTING FUSES.

LEFT VALVE SOLENOID- 3 AMP FUSE  
RIGHT VALVE SOLENOID- 3 AMP FUSE  
DUMP VALVE SOLENOID- 3 AMP FUSE  
FRONT VALVE SOLENOID- 3 AMP FUSE

REMOVE: TO REMOVE FUSE, USE FUSE PULLER OR NEEDLE NOSE PLIERS AND PULL FUSE STRAIGHT OUT.

INSTALL: TO INSTALL FUSE, USE FUSE PULLER, NEEDLE NOSE PLIERS, OR YOUR HAND TO INSERT THE FUSE MAKING SURE PINS ON FUSE ENTER RECEPTACLE CORRECTLY.
