## **T.I.P. Troubleshooting Information on Power Gear**

### **SYNCHRONIZING A 2 RAIL SLIDE-OUT ROOM WITH A COLLARED DRIVE SHAFT ASSEMBLY**

**NOTE- This Tip Sheet covers low profile slide-out systems with a collared drive shaft assembly.**

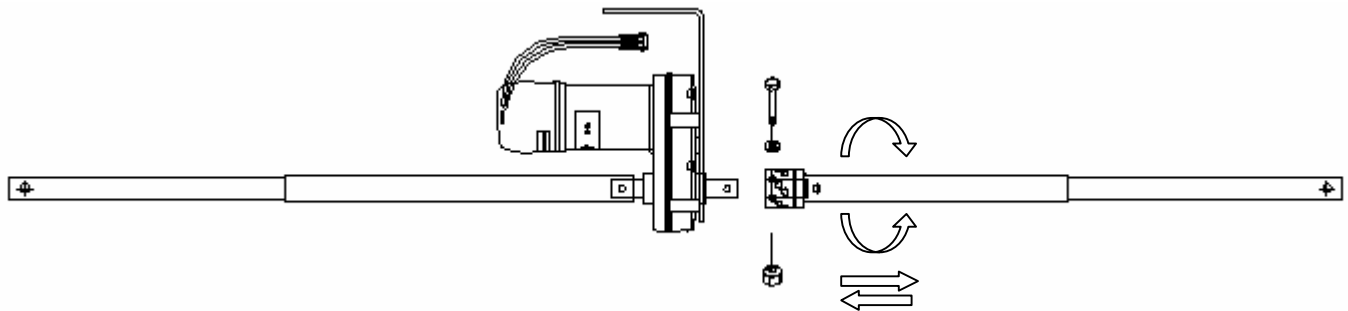
To synchronize the room please refer to the Figure below.

With room about half way out, release slide-out motor brake.

1. Unbolt the nut / bolt / washer assembly on the collared drive shaft
2. Using an adjustable wrench, turn the collared drive shaft clockwise or counterclockwise to move that end of the room to the desired location.
3. Check the timing of the room for accuracy.
4. While rotating the collared shaft move it in or out to align the closest collar hole with the motor shaft hole.
5. Re-install the nut / bolt / washer assembly and torque per specifications in appropriate TIP sheet.
6. Check timing. Room should be within  $\frac{1}{4}$ " of even. If not repeat steps 2 through 6 .
7. Move motor brake to "Engaged" position.
